# Access Compliance Report

## Public Rights-of-Way

| Intersection ID: 5606 | Main Street: JOHN_KIRK_DR | Cross Street: CAMERON_BV | Location: | N |
| ADA ID: 9463239AD4F0 | Ramp Type: Directional1 | Initial Pass/Fail: Pass | Overall Compliance: No | Severity Score: 2.5 |

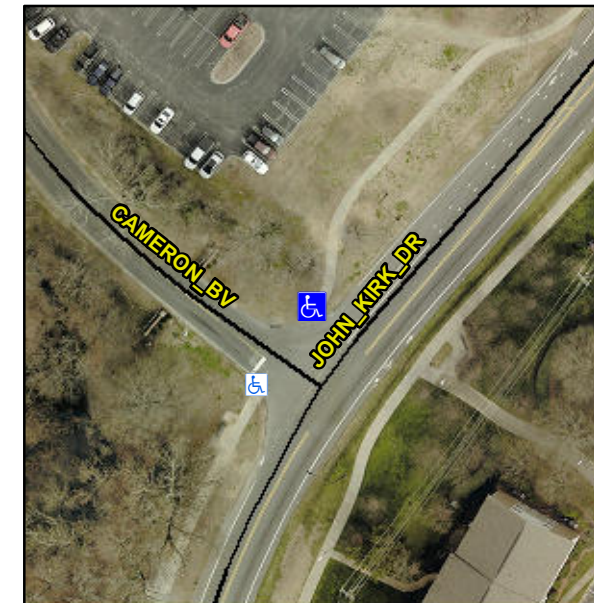
**NO CURB**

**R305.1.4, R305.2**

| Compliance | Description | Data | Compliance | Description | Data |
|---|---|---|---|---|---|
| Yes | Landing X Slope (%) | 1.5 | No | DWS Full Width? | No |
| N/A | Landing Curb? (Y/N) | No | No | DWS Offset LT (in) | 88.0 |
| N/A | Shared Landing? | No | No | DWS Offset RT (in) | 34.0 |

**Remove & Replace Detectable Warning System.**

Total Cost: \$ 800.00
