Access Compliance Report

Public Rights-of-Way

(Curb Ramps)

Intersection ID: 16828	Main Street: BUCKNELL_AV	Cross Street: SELWYN_AV	Location: NE
ADA ID: 94806C461A87	Ramp Type: Perp	Initial Pass/Fail: Fail	Overall Compliance: No
Codes/Mitigation Info/Possible Solution		Field Measurements/Component Compliance	
Severity Score: 33.75

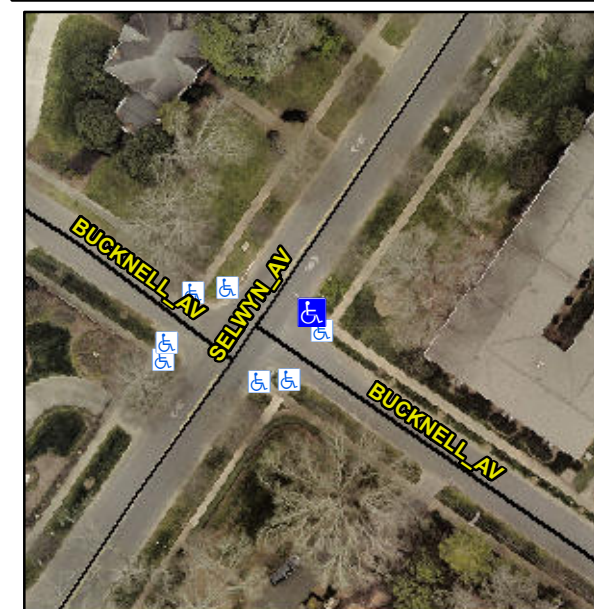
Not Found, R304.5.1, R304.2.2, R304.5.3

Compliance	Description	Data	Compliance	Description	Data
N/A	Ramp Length (in)	59.5	No	Ramp Slope (%)	9.2
No	Ramp Width (in)	43.0	No	Ramp XSlope (%)	5.5
N/A	Flare Type LT	N/A	N/A	Flare Type RT	N/A
N/A	Flare Slope LT (%)	N/A	N/A	Flare Slope RT (%)	N/A
N/A	Flare Traversable LT?	N/A	N/A	Flare Traversable RT?	N/A
N/A	Landing Length (in)	N/A	N/A	DWS Provided?	N/A
N/A	Landing Width (in)	N/A	N/A	DWS Contrast?	N/A
N/A	Landing Slope (%)	N/A	N/A	DWS Length (in)	N/A
N/A	Landing X Slope (%)	N/A	N/A	DWS Full Width?	N/A
N/A	Landing Curb? (Y/N)	N/A	N/A	DWS Offset (in)	N/A
N/A	Shared Landing?	N/A			
N/A	Gutter Ponding?	N/A	N/A	Gutter Slope (%)	N/A
N/A	Gutter Lip Ht (in)	N/A	N/A	Gutter X Slope (%)	N/A
N/A	Painted X Walk1?	No	N/A	Painted X Walk2?	N/A
	X Walk 1 Direction	To NW		X Walk 2 Direction	N/A
N/A	X Walk 1 Width (in)	N/A	N/A	X Walk 2 Width (in)	N/A
	X Walk 1 Slope (%)	5.3		X Walk 2 Slope (%)	N/A
	X Walk 1 X Slope (%)	2.3		X Walk 2 X Slope (%)	N/A

N/A	Ramp inside XWalk1?	N/A	N/A	Ramp inside XWalk2?	N/A
	Road Slope (%)	N/A	N/A	Clear Space?	N/A
	Road X Slope (%)	N/A	N/A	Clear Space to XWalk (in)	N/A
N/A	Any Obstructions?	N/A	N/A	Storm Grate/Utility Hazard?	N/A
	Obstruction Type			Storm Grate/Utility Type	
		N/A			N/A
			Yes	Surface Condition? (G/P)	Good

Possible Solutions:

Remove & Replace Entire Ramp.
