Access Compliance Report Public Rights-of-Way (Curb Ramps)

Main Street: E W T HARRIS BV **Cross Street: N/A** Location: Intersection ID: 10025558 NW Ramp Type: BlendTrans1 Initial Pass/Fail: Fail **Overall Compliance: No Severity Score:** 1.25 ADA ID: 94873137A894

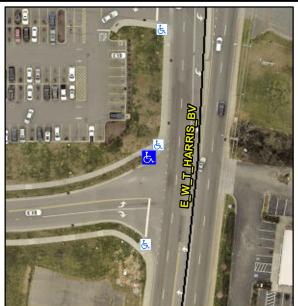
N/A	Flare Type LT	N/A	N/A	Flare Type RT	N/A
N/A	Flare Slope LT (%)	N/A	N/A	Flare Slope RT (%)	N/A
N/A	Flare Traversable LT?	N/A	N/A	Flare Traversable RT?	N/A
N/A	Landing Length (in)	N/A	N/A	DWS Provided?	N/A
N/A	Landing Width (in)	N/A	N/A	DWS Contrast?	N/A
N/A	Landing Slope (%)	N/A	N/A	DWS Length (in)	N/A
N/A	Landing X Slope (%)	N/A	N/A	DWS Full Width?	N/A
N/A	Landing Curb? (Y/N)	N/A	N/A	DWS Offset (in)	N/A
N/A	Shared Landing?	N/A			
N/A	Gutter Ponding?	N/A	N/A	Gutter Slope (%)	N/A
N/A	Gutter Lip Ht (in)	N/A	N/A	Gutter X Slope (%)	N/A
N/A	Painted X Walk1?	No	N/A	Painted X Walk2?	N/A
	X Walk 1 Direction	To S		X Walk 2 Direction	N/A
	X Walk 1 Width (in)	N/A		X Walk 2 Width (in)	N/A
	X Walk 1 Slope (%)	0.5		X Walk 2 Slope (%)	N/A
	X Walk 1 X Slope (%)	2.2		X Walk 2 X Slope (%)	N/A
N/A	Ramp inside XWalk1?	N/A	N/A	Ramp inside XWalk2?	N/A
	Road Slope (%)	2.2		Clear Space?	N/A
	Road X Slope (%)	0.5	N/A	Clear Space to XWalk (in)	N/A

N/A	Any Obstructions?	N/A	N/A	Storm Grate/Utility Hazard?	N/A
	Obstruction Type			Storm Grate/Utility Type	
		N/A			N/A
			Yes	Surface Condition? (G/P)	Good
Total Control	and later		No	Curb Slope (%)	14.2

Possible Solutions: Compliance Description **Remove & Replace Curb Ramp With** N/A Two New Directional Ramps or Yes Equivalent. Surveyor Notes: N/A PROW/ADA: Not Found, R304.5.3
