# Access Compliance Report

## Public Rights-of-Way

### (Curb Ramps)

| Intersection ID: 20396 | Main Street: MEDEARIS_DR | Cross Street: SARDIS_RD | Location: SE |

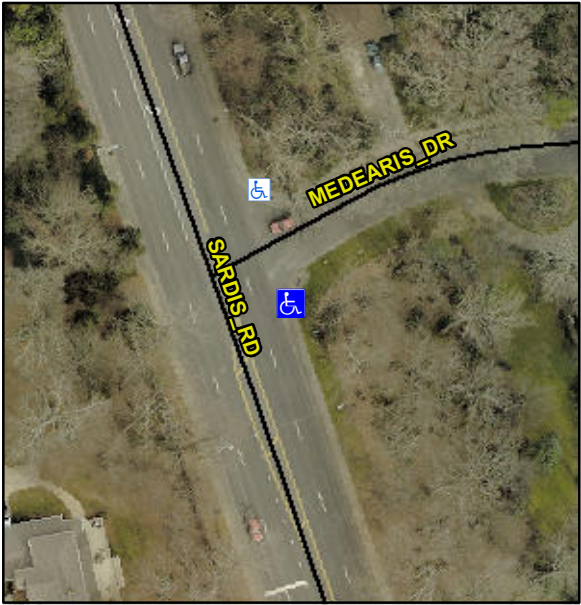
| ADA ID: 9494D9316D7D | Ramp Type: PerpDiag | Initial Pass/Fail: Fail | Overall Compliance: No |

| Codes/Mitigation Info/Possible Solution | | | Field Measurements/Component Compliance | | |
|---|---|--|---|---|---|
| | <b>Remove &amp; Replace Curb Ramp With Two New Directional Ramps or Equivalent.</b> | | <b>No</b> | Ramp Length (in) | <b>57.0</b> |
| | | | <b>No</b> | Ramp Width (in) | <b>42.0</b> |
| <p>Surveyor Notes:</p> <p><b>N/A</b></p> <p>PROW/ADA:</p> <p><b>R304.5.1, R304.2.2</b></p> | | | <b>N/A</b> | Flare Type RT | <b>N/A</b> |

| Codes/Mitigation Info/Possible Solution | | | Field Measurements/Component Compliance | | |
|---|---|--|---|---|---|
| <p>Total Cost:</p> <p><b>\$ 3200.00</b></p> | | | <b>No</b> | Painted X Walk1? | <b>No</b> |
