Access Compliance Report

Public Rights-of-Way

(Curb Ramps)

Intersection ID: 7993	Main Street: AMERON_DR	Cross Street: N_GRAHAM_ST	Location: SE
ADA ID: 94975B211C9F	Ramp Type: Perp	Initial Pass/Fail: Fail	Overall Compliance: No
		Severity Score: 12.5

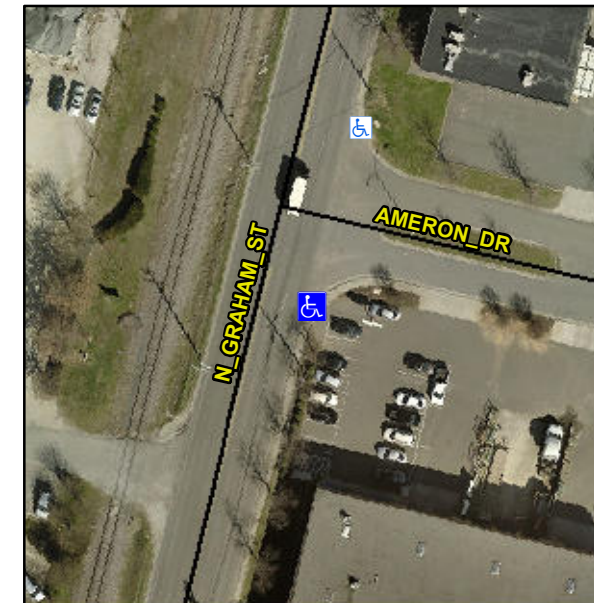
Not Found, R304.2.2

Compliance	Description	Data	Compliance	Description	Data
N/A	Ramp Length (in)	46.0	No	Ramp Slope (%)	9.3
Yes	Ramp Width (in)	60.0	Yes	Ramp XSlope (%)	0.6
N/A	Flare Type LT	N/A	N/A	Flare Type RT	N/A
N/A	Flare Slope LT (%)	N/A	N/A	Flare Slope RT (%)	N/A
N/A	Flare Traversable LT?	N/A	N/A	Flare Traversable RT?	N/A
N/A	Landing Length (in)	N/A	N/A	DWS Provided?	N/A
N/A	Landing Width (in)	N/A	N/A	DWS Contrast?	N/A
N/A	Landing Slope (%)	N/A	N/A	DWS Length (in)	N/A
N/A	Landing X Slope (%)	N/A	N/A	DWS Full Width?	N/A
N/A	Landing Curb? (Y/N)	N/A	N/A	DWS Offset (in)	N/A
N/A	Shared Landing?	N/A			
N/A	Gutter Ponding?	N/A	N/A	Gutter Slope (%)	N/A
N/A	Gutter Lip Ht (in)	0.75	N/A	Gutter X Slope (%)	N/A
N/A	Painted X Walk1?	No	N/A	Painted X Walk2?	N/A
	X Walk 1 Direction	To NE		X Walk 2 Direction	N/A
N/A	X Walk 1 Width (in)	N/A	N/A	X Walk 2 Width (in)	N/A
	X Walk 1 Slope (%)	0.9		X Walk 2 Slope (%)	N/A
	X Walk 1 X Slope (%)	0.1		X Walk 2 X Slope (%)	N/A

N/A	Ramp inside XWalk1?	N/A	N/A	Ramp inside XWalk2?	N/A
	Road Slope (%)	N/A	N/A	Clear Space?	N/A
	Road X Slope (%)	N/A	N/A	Clear Space to XWalk (in)	N/A
N/A	Any Obstructions?	N/A	N/A	Storm Grate/Utility Hazard?	N/A
	Obstruction Type			Storm Grate/Utility Type	
		N/A			N/A
			Yes	Surface Condition? (G/P)	Good

Possible Solutions:

Remove & Replace Entire Ramp.

Total Cost: \$ 1850.00
