# Access Compliance Report

## Public Rights-of-Way (Curb Ramps)

Intersection ID: 29715	Main Street: MEDOC_MOUNTAIN_DR	Cross Street: WILSON_DR	Location: E
ADA ID: 949D8A1A4E61	Ramp Type: Perp	Initial Pass/Fail: Fail	Overall Compliance: No
Severity Score: 21.25			
Codes/Mitigation Info/Possible Solution		Field Measurements/Component Compliance

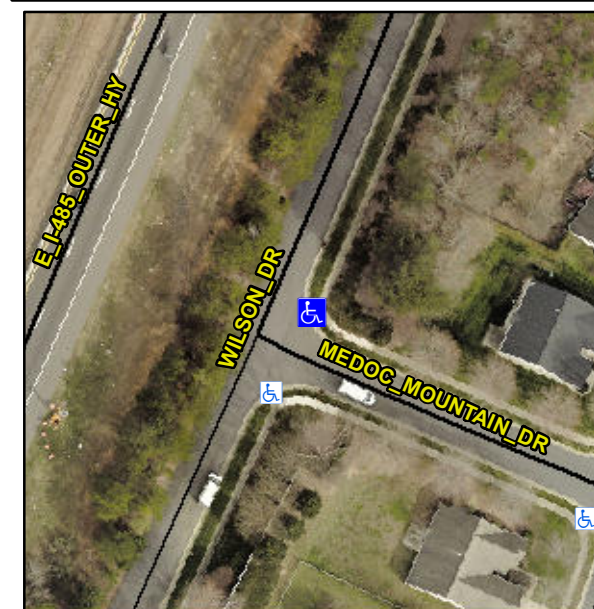
**Not Found, R304.5.1, R304.5.3**

Compliance	Description	Data	Compliance	Description	Data
N/A	Ramp Length (in)	54.0	Yes	Ramp Slope (%)	5.8
No	Ramp Width (in)	46.0	No	Ramp XSlope (%)	6.3
N/A	Flare Type LT	N/A	N/A	Flare Type RT	N/A
N/A	Flare Slope LT (%)	N/A	N/A	Flare Slope RT (%)	N/A
N/A	Flare Traversable LT?	N/A	N/A	Flare Traversable RT?	N/A
N/A	Landing Length (in)	N/A	N/A	DWS Provided?	N/A
N/A	Landing Width (in)	N/A	N/A	DWS Contrast?	N/A
N/A	Landing Slope (%)	N/A	N/A	DWS Length (in)	N/A
N/A	Landing X Slope (%)	N/A	N/A	DWS Full Width?	N/A
N/A	Landing Curb? (Y/N)	N/A	N/A	DWS Offset (in)	N/A
N/A	Shared Landing?	N/A			
N/A	Gutter Ponding?	N/A	N/A	Gutter Slope (%)	N/A
N/A	Gutter Lip Ht (in)	N/A	N/A	Gutter X Slope (%)	N/A
N/A	Painted X Walk1?	No	N/A	Painted X Walk2?	N/A
	X Walk 1 Direction	To SW		X Walk 2 Direction	N/A
N/A	X Walk 1 Width (in)	N/A	N/A	X Walk 2 Width (in)	N/A
	X Walk 1 Slope (%)	0.5		X Walk 2 Slope (%)	N/A
	X Walk 1 X Slope (%)	5.3		X Walk 2 X Slope (%)	N/A

N/A	Ramp inside XWalk1?	N/A	N/A	Ramp inside XWalk2?	N/A
	Road Slope (%)	N/A	N/A	Clear Space?	N/A
	Road X Slope (%)	N/A	N/A	Clear Space to XWalk (in)	N/A
N/A	Any Obstructions?	N/A	N/A	Storm Grate/Utility Hazard?	N/A
	Obstruction Type			Storm Grate/Utility Type	
		N/A			N/A
			Yes	Surface Condition? (G/P)	Good

**Remove & Replace Entire Ramp.**

Total Cost: \$ 1850.00
