# Access Compliance Report

## Public Rights-of-Way

### (Curb Ramps)

Intersection ID: 10033749	Main Street: OVERLOOK_MOUNTAIN_DR	Cross Street: N/A	Location: NE
ADA ID: 94A160C1594D	Ramp Type: Perp	Initial Pass/Fail: Fail	Overall Compliance: No
Severity Score: 12.5			
Codes/Mitigation Info/Possible Solution		Field Measurements/Component Compliance

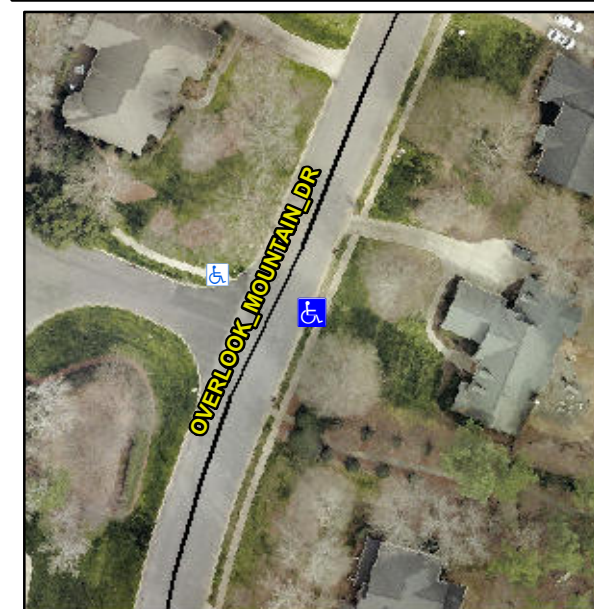
Compliance	Description	Data	Compliance	Description	Data
N/A	Ramp Length (in)	94.0	No	Ramp Slope (%)	8.4
Yes	Ramp Width (in)	48.0	Yes	Ramp XSlope (%)	0.1
N/A	Flare Type LT	N/A	N/A	Flare Type RT	N/A
N/A	Flare Slope LT (%)	N/A	N/A	Flare Slope RT (%)	N/A
N/A	Flare Traversable LT?	N/A	N/A	Flare Traversable RT?	N/A
N/A	Landing Length (in)	N/A	N/A	DWS Provided?	N/A
N/A	Landing Width (in)	N/A	N/A	DWS Contrast?	N/A
N/A	Landing Slope (%)	N/A	N/A	DWS Length (in)	N/A
N/A	Landing X Slope (%)	N/A	N/A	DWS Full Width?	N/A
N/A	Landing Curb? (Y/N)	N/A	N/A	DWS Offset (in)	N/A
N/A	Shared Landing?	N/A			
N/A	Gutter Ponding?	N/A	N/A	Gutter Slope (%)	N/A
N/A	Gutter Lip Ht (in)	N/A	N/A	Gutter X Slope (%)	N/A
N/A	Painted X Walk1?	No	N/A	Painted X Walk2?	N/A
	X Walk 1 Direction	To NW		X Walk 2 Direction	N/A
N/A	X Walk 1 Width (in)	N/A	N/A	X Walk 2 Width (in)	N/A
	X Walk 1 Slope (%)	0.7		X Walk 2 Slope (%)	N/A
	X Walk 1 X Slope (%)	3.1		X Walk 2 X Slope (%)	N/A

N/A	Ramp inside XWalk1?	N/A	N/A	Ramp inside XWalk2?	N/A
	Road Slope (%)	N/A	N/A	Clear Space?	N/A
	Road X Slope (%)	N/A	N/A	Clear Space to XWalk (in)	N/A
N/A	Any Obstructions?	N/A	N/A	Storm Grate/Utility Hazard?	N/A
	Obstruction Type			Storm Grate/Utility Type	
		N/A			N/A
			Yes	Surface Condition? (G/P)	Good

Possible Solutions:

**Remove & Replace Entire Ramp.**

**R304.2.2**

**\$ 1850.00**
