# Access Compliance Report

## Public Rights-of-Way

### (Curb Ramps)

Intersection ID: 3248	Main Street: METROMONT INDUSTRIAL BV	Cross Street: METROMONT PY	Location: NW
ADA ID: 94B567E492D5	Ramp Type: Perp	Initial Pass/Fail: Fail	Overall Compliance: No
Severity Score: 21.25			
Codes/Mitigation Info/Possible Solution		Field Measurements/Component Compliance

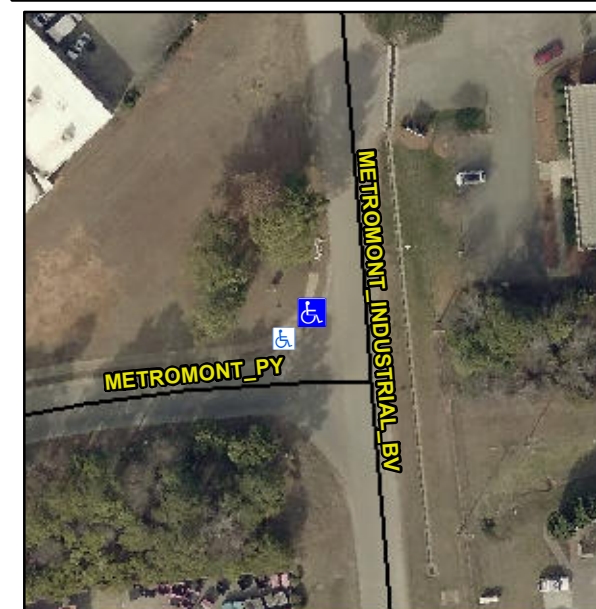
**R304.5.1, R304.2.2**

Compliance	Description	Data	Compliance	Description	Data
N/A	Ramp Length (in)	47.0	No	Ramp Slope (%)	9.9
No	Ramp Width (in)	43.5	Yes	Ramp XSlope (%)	0.1
N/A	Flare Type LT	N/A	N/A	Flare Type RT	N/A
N/A	Flare Slope LT (%)	N/A	N/A	Flare Slope RT (%)	N/A
N/A	Flare Traversable LT?	N/A	N/A	Flare Traversable RT?	N/A
N/A	Landing Length (in)	N/A	N/A	DWS Provided?	N/A
N/A	Landing Width (in)	N/A	N/A	DWS Contrast?	N/A
N/A	Landing Slope (%)	N/A	N/A	DWS Length (in)	N/A
N/A	Landing X Slope (%)	N/A	N/A	DWS Full Width?	N/A
N/A	Landing Curb? (Y/N)	N/A	N/A	DWS Offset (in)	N/A
N/A	Shared Landing?	N/A			
N/A	Gutter Ponding?	N/A	N/A	Gutter Slope (%)	N/A
N/A	Gutter Lip Ht (in)	N/A	N/A	Gutter X Slope (%)	N/A
N/A	Painted X Walk1?	No	N/A	Painted X Walk2?	N/A
	X Walk 1 Direction	To E		X Walk 2 Direction	N/A
N/A	X Walk 1 Width (in)	N/A	N/A	X Walk 2 Width (in)	N/A
	X Walk 1 Slope (%)	4.3		X Walk 2 Slope (%)	N/A
	X Walk 1 X Slope (%)	6.0		X Walk 2 X Slope (%)	N/A

N/A	Ramp inside XWalk1?	N/A	N/A	Ramp inside XWalk2?	N/A
	Road Slope (%)	N/A	N/A	Clear Space?	N/A
	Road X Slope (%)	N/A	N/A	Clear Space to XWalk (in)	N/A
N/A	Any Obstructions?	N/A	N/A	Storm Grate/Utility Hazard?	N/A
	Obstruction Type			Storm Grate/Utility Type	
		N/A			N/A
			Yes	Surface Condition? (G/P)	Good

**Remove & Replace Entire Ramp.**

Total Cost: \$ 1850.00
