Access Compliance Report

Public Rights-of-Way

(Curb Ramps)

Intersection ID: 5966	Main Street: SUNSTONE_DR	Cross Street: STATESVILLE_RD	Location: SW
ADA ID: 94B78589FED7	Ramp Type: Perp	Initial Pass/Fail: Fail	Overall Compliance: No
		Severity Score: 8.75

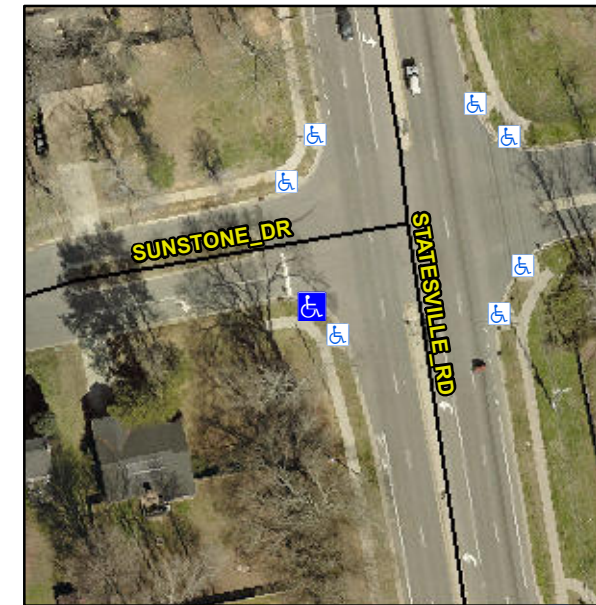
Compliance	Description	Data	Compliance	Description	Data
N/A	Ramp Length (in)	97.0	Yes	Ramp Slope (%)	7.4
No	Ramp Width (in)	47.5	Yes	Ramp XSlope (%)	1.0
N/A	Flare Type LT	N/A	N/A	Flare Type RT	N/A
N/A	Flare Slope LT (%)	N/A	N/A	Flare Slope RT (%)	N/A
N/A	Flare Traversable LT?	N/A	N/A	Flare Traversable RT?	N/A
N/A	Landing Length (in)	N/A	N/A	DWS Provided?	N/A
N/A	Landing Width (in)	N/A	N/A	DWS Contrast?	N/A
N/A	Landing Slope (%)	N/A	N/A	DWS Length (in)	N/A
N/A	Landing X Slope (%)	N/A	N/A	DWS Full Width?	N/A
N/A	Landing Curb? (Y/N)	N/A	N/A	DWS Offset (in)	N/A
N/A	Shared Landing?	N/A			
N/A	Gutter Ponding?	N/A	N/A	Gutter Slope (%)	N/A
N/A	Gutter Lip Ht (in)	N/A	N/A	Gutter X Slope (%)	N/A
N/A	Painted X Walk1?	No	N/A	Painted X Walk2?	N/A
	X Walk 1 Direction	To N		X Walk 2 Direction	N/A
N/A	X Walk 1 Width (in)	N/A	N/A	X Walk 2 Width (in)	N/A
	X Walk 1 Slope (%)	0.3		X Walk 2 Slope (%)	N/A
	X Walk 1 X Slope (%)	3.2		X Walk 2 X Slope (%)	N/A

N/A	Ramp inside XWalk1?	N/A	N/A	Ramp inside XWalk2?	N/A
	Road Slope (%)	N/A	N/A	Clear Space?	N/A
	Road X Slope (%)	N/A	N/A	Clear Space to XWalk (in)	N/A
N/A	Any Obstructions?	N/A	N/A	Storm Grate/Utility Hazard?	N/A
	Obstruction Type			Storm Grate/Utility Type	
		N/A			N/A
			Yes	Surface Condition? (G/P)	Good

Possible Solutions:

Remove & Replace Entire Ramp.

R304.5.1
