Access Compliance Report

Public Rights-of-Way

(Curb Ramps)

Intersection ID: 52583	Main Street: NEW_RENAISSANCE_WY	Cross Street: N/A	Location: SW
ADA ID: 94B98C6EEBB5	Ramp Type: Perp	Initial Pass/Fail: Fail	Overall Compliance: No
Severity Score: 37.5			
Codes/Mitigation Info/Possible Solution		Field Measurements/Component Compliance

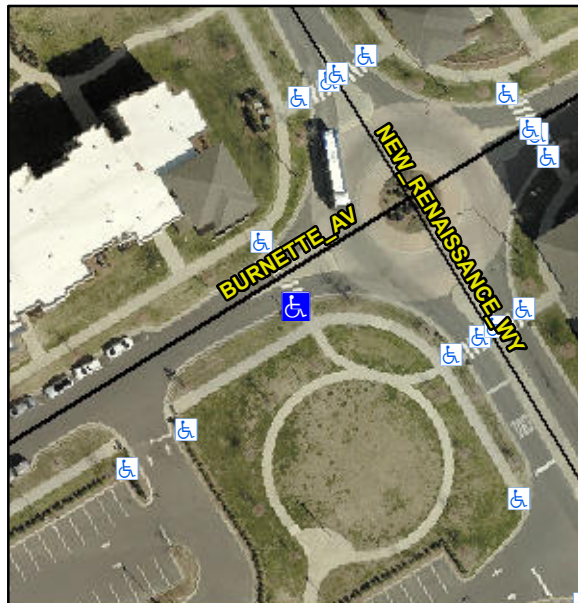
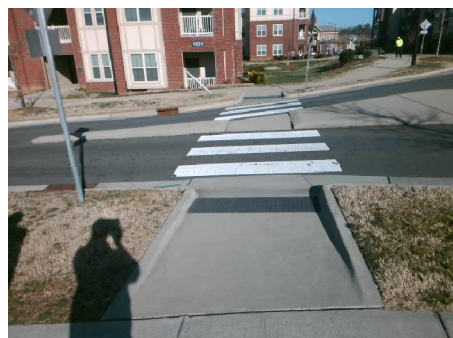
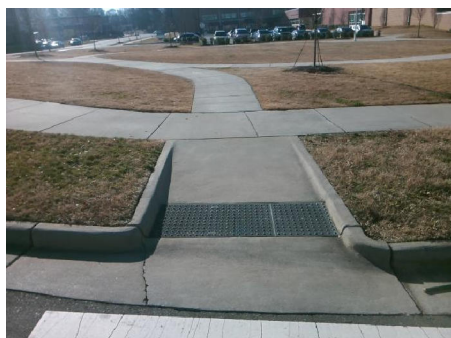
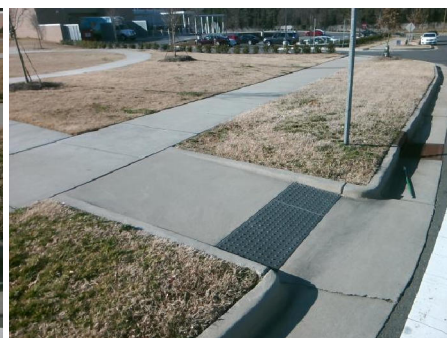
R304.2.2, R304.5.3

Compliance	Description	Data	Compliance	Description	Data
N/A	Ramp Length (in)	102.0	No	Ramp Slope (%)	8.9
Yes	Ramp Width (in)	72.0	No	Ramp XSlope (%)	7.7
N/A	Flare Type LT	N/A	N/A	Flare Type RT	N/A
N/A	Flare Slope LT (%)	N/A	N/A	Flare Slope RT (%)	N/A
N/A	Flare Traversable LT?	N/A	N/A	Flare Traversable RT?	N/A
N/A	Landing Length (in)	N/A	N/A	DWS Provided?	N/A
N/A	Landing Width (in)	N/A	N/A	DWS Contrast?	N/A
N/A	Landing Slope (%)	N/A	N/A	DWS Length (in)	N/A
N/A	Landing X Slope (%)	N/A	N/A	DWS Full Width?	N/A
N/A	Landing Curb? (Y/N)	N/A	N/A	DWS Offset (in)	N/A
N/A	Shared Landing?	N/A			
N/A	Gutter Ponding?	N/A	N/A	Gutter Slope (%)	N/A
N/A	Gutter Lip Ht (in)	N/A	N/A	Gutter X Slope (%)	N/A
N/A	Painted X Walk1?	Yes	N/A	Painted X Walk2?	N/A
	X Walk 1 Direction	To NW		X Walk 2 Direction	N/A
N/A	X Walk 1 Width (in)	120.0	N/A	X Walk 2 Width (in)	N/A
	X Walk 1 Slope (%)	5.3		X Walk 2 Slope (%)	N/A
	X Walk 1 X Slope (%)	6.8		X Walk 2 X Slope (%)	N/A

N/A	Ramp inside XWalk1?	Yes	N/A	Ramp inside XWalk2?	N/A
	Road Slope (%)	N/A	N/A	Clear Space?	N/A
	Road X Slope (%)	N/A	N/A	Clear Space to XWalk (in)	N/A
N/A	Any Obstructions?	N/A	N/A	Storm Grate/Utility Hazard?	N/A
	Obstruction Type			Storm Grate/Utility Type	
		N/A			N/A
		Yes		Surface Condition? (G/P)	Good

Remove & Replace Entire Ramp.

Total Cost: \$ 1850.00
