# Access Compliance Report

## Public Rights-of-Way

### (Curb Ramps)

Intersection ID: 51342	Main Street: MCMULLEN_WY	Cross Street: MONROE_RD	Location:	SE
ADA ID: 94C0D81981CB	Ramp Type: PerpDiag	Initial Pass/Fail: Fail	Overall Compliance: No	Severity Score: 22.5
Codes/Mitigation Info/Possible Solution		Field Measurements/Component Compliance

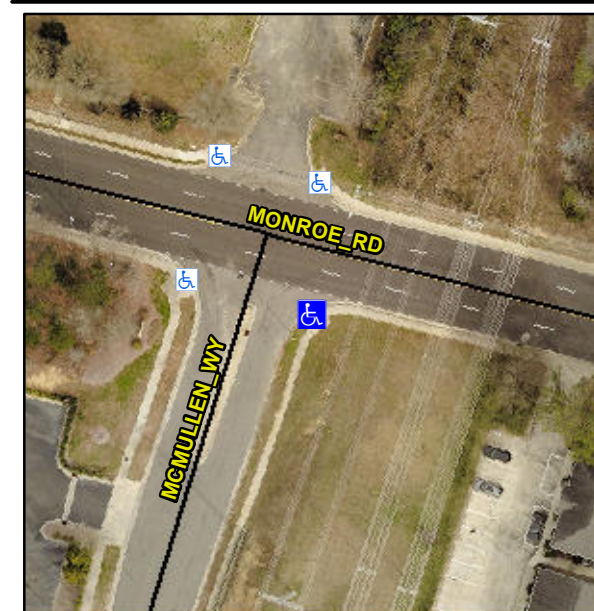
**Not Found, R304.5.1, R304.2.2, R304.5.3**

Compliance	Description	Data	Compliance	Description	Data
N/A	Ramp Length (in)	59.0	No	Ramp Slope (%)	9.5
No	Ramp Width (in)	46.0	No	Ramp XSlope (%)	3.1
N/A	Flare Type LT	N/A	N/A	Flare Type RT	N/A
N/A	Flare Slope LT (%)	N/A	N/A	Flare Slope RT (%)	N/A
N/A	Flare Traversable LT?	N/A	N/A	Flare Traversable RT?	N/A
N/A	Landing Length (in)	N/A	N/A	DWS Provided?	N/A
N/A	Landing Width (in)	N/A	N/A	DWS Contrast?	N/A
N/A	Landing Slope (%)	N/A	N/A	DWS Length (in)	N/A
N/A	Landing X Slope (%)	N/A	N/A	DWS Full Width?	N/A
N/A	Landing Curb? (Y/N)	N/A	N/A	DWS Offset (in)	N/A
N/A	Shared Landing?	N/A			
N/A	Gutter Ponding?	N/A	N/A	Gutter Slope (%)	N/A
N/A	Gutter Lip Ht (in)	N/A	N/A	Gutter X Slope (%)	N/A
N/A	Painted X Walk1?	No	N/A	Painted X Walk2?	No
	X Walk 1 Direction	To NE		X Walk 2 Direction	To NW
N/A	X Walk 1 Width (in)	N/A	N/A	X Walk 2 Width (in)	N/A
	X Walk 1 Slope (%)	1.4		X Walk 2 Slope (%)	3.8
	X Walk 1 X Slope (%)	4.4		X Walk 2 X Slope (%)	4.1

N/A	Ramp inside XWalk1?	N/A	N/A	Ramp inside XWalk2?	N/A
	Road Slope (%)	4.6	N/A	Clear Space?	N/A
	Road X Slope (%)	0.8	N/A	Clear Space to XWalk (in)	N/A
N/A	Any Obstructions?	N/A	N/A	Storm Grate/Utility Hazard?	N/A
	Obstruction Type			Storm Grate/Utility Type	
		N/A			N/A
			Yes	Surface Condition? (G/P)	Good

**Remove & Replace Curb Ramp With Two New Directional Ramps or Equivalent.**
