# Access Compliance Report

## Public Rights-of-Way

### (Curb Ramps)

Intersection ID: 10161	Main Street: E_35TH_ST	Cross Street: YADKIN_AV	Location: S
ADA ID: 94C93CBC8CBC	Ramp Type: PerpDiag	Initial Pass/Fail: Fail	Overall Compliance: No
		Severity Score: 22.5

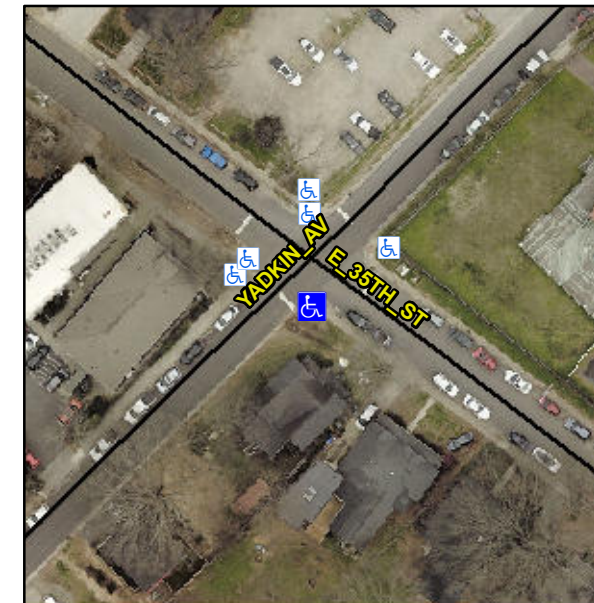
**Not Found, R304.5.1, R304.2.2, R304.5.3**

Compliance	Description	Data	Compliance	Description	Data
N/A	Ramp Length (in)	25.5	No	Ramp Slope (%)	9.8
No	Ramp Width (in)	47.5	No	Ramp XSlope (%)	2.2
N/A	Flare Type LT	N/A	N/A	Flare Type RT	N/A
N/A	Flare Slope LT (%)	N/A	N/A	Flare Slope RT (%)	N/A
N/A	Flare Traversable LT?	N/A	N/A	Flare Traversable RT?	N/A
N/A	Landing Length (in)	N/A	N/A	DWS Provided?	N/A
N/A	Landing Width (in)	N/A	N/A	DWS Contrast?	N/A
N/A	Landing Slope (%)	N/A	N/A	DWS Length (in)	N/A
N/A	Landing X Slope (%)	N/A	N/A	DWS Full Width?	N/A
N/A	Landing Curb? (Y/N)	N/A	N/A	DWS Offset (in)	N/A
N/A	Shared Landing?	N/A			
N/A	Gutter Ponding?	N/A	N/A	Gutter Slope (%)	N/A
N/A	Gutter Lip Ht (in)	N/A	N/A	Gutter X Slope (%)	N/A
N/A	Painted X Walk1?	No	N/A	Painted X Walk2?	No
	X Walk 1 Direction	To NE		X Walk 2 Direction	To NW
N/A	X Walk 1 Width (in)	N/A	N/A	X Walk 2 Width (in)	N/A
	X Walk 1 Slope (%)	5.3		X Walk 2 Slope (%)	1.0
	X Walk 1 X Slope (%)	0.7		X Walk 2 X Slope (%)	2.8

N/A	Ramp inside XWalk1?	N/A	N/A	Ramp inside XWalk2?	N/A
	Road Slope (%)	3.8	N/A	Clear Space?	N/A
	Road X Slope (%)	4.6	N/A	Clear Space to XWalk (in)	N/A
N/A	Any Obstructions?	N/A	N/A	Storm Grate/Utility Hazard?	N/A
	Obstruction Type			Storm Grate/Utility Type	
		N/A			N/A
			Yes	Surface Condition? (G/P)	Good

**Remove & Replace Curb Ramp With Two New Directional Ramps or Equivalent.**
