Access Compliance Report

Public Rights-of-Way

(Curb Ramps)

Intersection ID: 24067	Main Street: REA_RD	Cross Street: SUMMERLIN_PL	Location: SE
ADA ID: 94CCFBF0EC1D	Ramp Type: Directional1	Initial Pass/Fail: Fail	Overall Compliance: No
Severity Score: 1.25			
Codes/Mitigation Info/Possible Solution		Field Measurements/Component Compliance

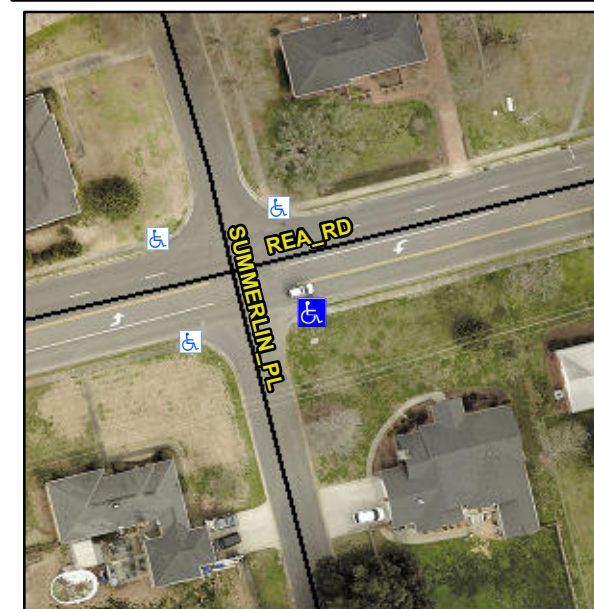
Compliance	Description	Data	Compliance	Description	Data
N/A	Ramp Length (in)	39.0	N/A	Grade Break?	N/A
Yes	Ramp Width (in)	48.0	N/A	Grade Break Slope (%)	0.0
Yes	Ramp Slope (%)	8.0	N/A	Grade Break XSlope (%)	0.0
No	Ramp XSlope (%)	3.3			
N/A	Flare Type LT	N/A	N/A	Flare Type RT	N/A
N/A	Flare Slope LT (%)	N/A	N/A	Flare Slope RT (%)	0.0
N/A	Flare Traversable LT?	N/A	N/A	Flare Traversable RT?	N/A
N/A	Landing Length (in)	0.0	N/A	DWS Provided?	N/A
N/A	Landing Width (in)	0.0	N/A	DWS Contrast?	N/A
N/A	Landing Slope (%)	0.0	N/A	DWS Length (in)	N/A
N/A	Landing X Slope (%)	0.0	N/A	DWS Full Width?	N/A
N/A	Landing Curb? (Y/N)	N/A	N/A	DWS Offset LT (in)	N/A
N/A	Shared Landing?	N/A	N/A	DWS Offset RT (in)	N/A
N/A	Gutter Ponding?	0.0	N/A	Gutter Slope (%)	N/A
N/A	Gutter Lip Ht (in)	0.0	N/A	Gutter X Slope (%)	N/A
N/A	Painted X Walk1?	No		Road Slope (%)	2.0
	X Walk 1 Direction	To SW		Road X Slope (%)	0.5
	X Walk 1 Width (in)	N/A		Clear Space?	N/A

X Walk 1 Slope (%)	2.0	N/A	Clear Space to XWalk (in)	N/A
	X Walk 1 X Slope (%)	0.5	N/A	Storm Grate/Utility Hazard?	N/A
N/A	Ramp inside XWalk1?	N/A		Storm Grate/Utility Type	
N/A	Any Obstructions?	N/A			N/A
	Obstruction Type		Yes	Surface Condition? (G/P)	Good
			N/A	Curb Slope (%)	4.5

Possible Solutions:

Remove & Replace Entire Ramp.
