# Access Compliance Report

## Public Rights-of-Way

### (Curb Ramps)

Intersection ID: 45131	Main Street: PLAZA_RD_EXT	Cross Street: FOUR SISTERS_LN	Location: SW
ADA ID: 94E85A659F4F	Ramp Type: Perp	Initial Pass/Fail: Fail	Overall Compliance: No
Severity Score: 10			
Codes/Mitigation Info/Possible Solution		Field Measurements/Component Compliance

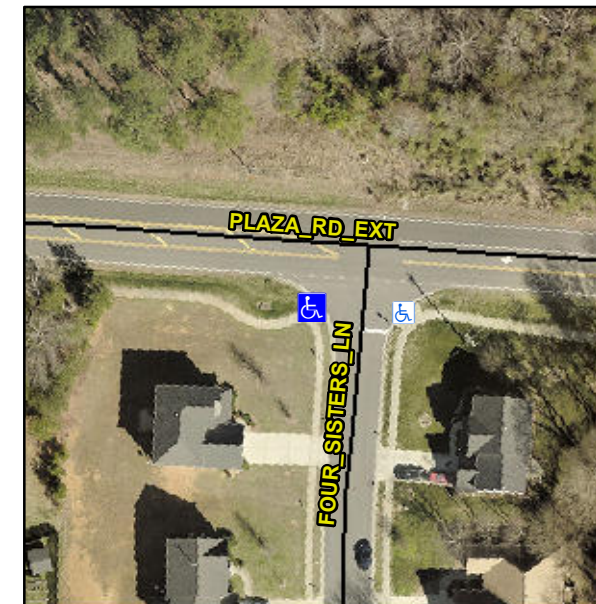
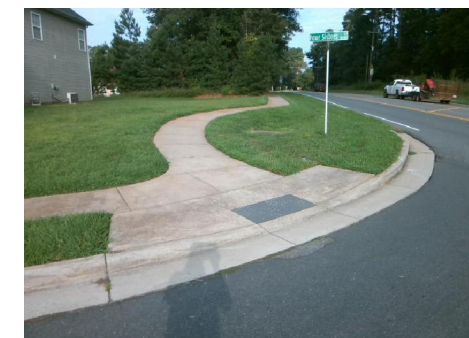
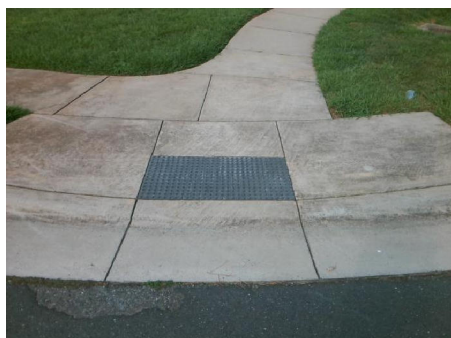
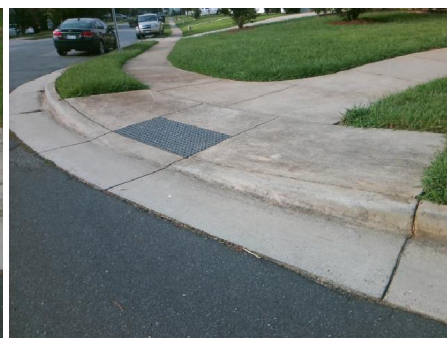
**Not Found, R304.5.1, R304.5.3**

Compliance	Description	Data	Compliance	Description	Data
N/A	Ramp Length (in)	52.0	Yes	Ramp Slope (%)	5.6
No	Ramp Width (in)	47.0	No	Ramp XSlope (%)	3.6
N/A	Flare Type LT	N/A	N/A	Flare Type RT	N/A
N/A	Flare Slope LT (%)	N/A	N/A	Flare Slope RT (%)	N/A
N/A	Flare Traversable LT?	N/A	N/A	Flare Traversable RT?	N/A
N/A	Landing Length (in)	N/A	N/A	DWS Provided?	N/A
N/A	Landing Width (in)	N/A	N/A	DWS Contrast?	N/A
N/A	Landing Slope (%)	N/A	N/A	DWS Length (in)	N/A
N/A	Landing X Slope (%)	N/A	N/A	DWS Full Width?	N/A
N/A	Landing Curb? (Y/N)	N/A	N/A	DWS Offset (in)	N/A
N/A	Shared Landing?	N/A			
N/A	Gutter Ponding?	N/A	N/A	Gutter Slope (%)	N/A
N/A	Gutter Lip Ht (in)	0.5	N/A	Gutter X Slope (%)	N/A
N/A	Painted X Walk1?	No	N/A	Painted X Walk2?	N/A
	X Walk 1 Direction	To SE		X Walk 2 Direction	N/A
N/A	X Walk 1 Width (in)	N/A	N/A	X Walk 2 Width (in)	N/A
	X Walk 1 Slope (%)	1.5		X Walk 2 Slope (%)	N/A
	X Walk 1 X Slope (%)	2.5		X Walk 2 X Slope (%)	N/A

N/A	Ramp inside XWalk1?	N/A	N/A	Ramp inside XWalk2?	N/A
	Road Slope (%)	N/A	N/A	Clear Space?	N/A
	Road X Slope (%)	N/A	N/A	Clear Space to XWalk (in)	N/A
N/A	Any Obstructions?	N/A	N/A	Storm Grate/Utility Hazard?	N/A
	Obstruction Type			Storm Grate/Utility Type	
		N/A			N/A
			Yes	Surface Condition? (G/P)	Good

Possible Solutions:

**Remove & Replace Entire Ramp.**

Total Cost: \$ 1850.00
