Intersection ID: 10041333	Main Street: WEST_BV	Cross Street: N/A	Location:	NW
ADA ID: 94F0064AFDCB	Ramp Type: Perp	Initial Pass/Fail: Fail	Overall Compliance: No	Severity Score: 12.5

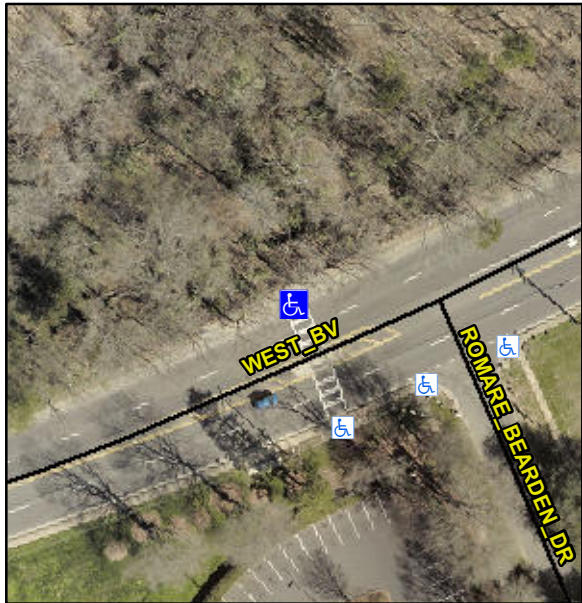
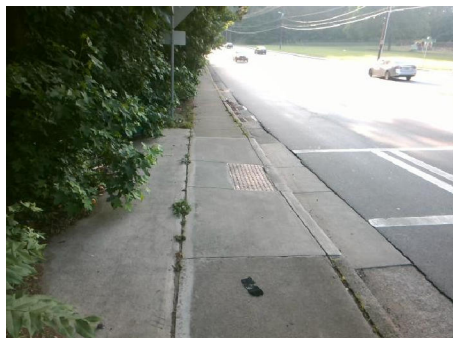
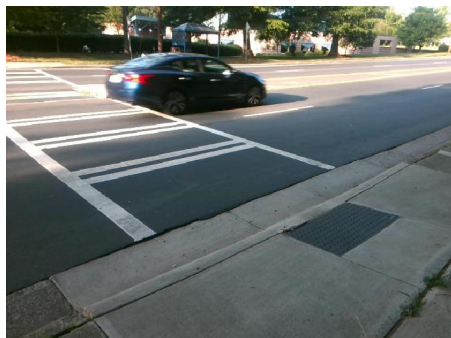
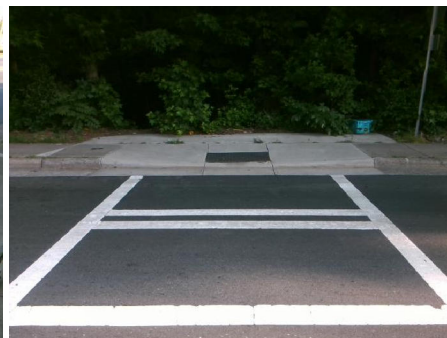
Possible Solutions:		Compliance	Description	Data	Compliance	Description	Data
	Remove & Replace Entire Ramp.		N/A	Ramp Length (in)	50.0	No	Ramp Slope (%)	10.3
			Yes	Ramp Width (in)	48.0	Yes	Ramp XSlope (%)	0.9
			N/A	Flare Type LT	N/A	N/A	Flare Type RT	N/A
			N/A	Flare Slope LT (%)	N/A	N/A	Flare Slope RT (%)	N/A
			N/A	Flare Traversable LT?	N/A	N/A	Flare Traversable RT?	N/A
			N/A	Landing Length (in)	N/A	N/A	DWS Provided?	N/A
Surveyor Notes:			N/A	Landing Width (in)	N/A	N/A	DWS Contrast?	N/A
	N/A		N/A	Landing Slope (%)	N/A	N/A	DWS Length (in)	N/A
			N/A	Landing X Slope (%)	N/A	N/A	DWS Full Width?	N/A
			N/A	Landing Curb? (Y/N)	N/A	N/A	DWS Offset (in)	N/A
			N/A	Shared Landing?	N/A			
PROW/ADA:			N/A	Gutter Ponding?	N/A	N/A	Gutter Slope (%)	N/A
Not Found, R304.2.2			N/A	Gutter Lip Ht (in)	N/A	N/A	Gutter X Slope (%)	N/A

N/A	Painted X Walk1?	Yes	N/A	Painted X Walk2?	N/A
				X Walk 1 Direction	To S		X Walk 2 Direction	N/A
			N/A	X Walk 1 Width (in)	118.0	N/A	X Walk 2 Width (in)	N/A
				X Walk 1 Slope (%)	0.9		X Walk 2 Slope (%)	N/A
				X Walk 1 X Slope (%)	1.0		X Walk 2 X Slope (%)	N/A
			N/A	Ramp inside XWalk1?	Yes	N/A	Ramp inside XWalk2?	N/A
				Road Slope (%)	N/A	N/A	Clear Space?	N/A
				Road X Slope (%)	N/A	N/A	Clear Space to XWalk (in)	N/A
			N/A	Any Obstructions?	N/A	N/A	Storm Grate/Utility Hazard?	N/A
				Obstruction Type			Storm Grate/Utility Type	
Total Cost:	\$	1850.00			N/A			N/A
						Yes	Surface Condition? (G/P)	Good
