Access Compliance Report

Public Rights-of-Way

(Curb Ramps)

Intersection ID: 48571	Main Street: DAPPLE_CT	Cross Street: SALAMANDER_RUN_LN	Location:	N
ADA ID: 94F109A6C5AA	Ramp Type: BlendTrans1	Initial Pass/Fail: Pass	Overall Compliance: No	Severity Score: 7.5

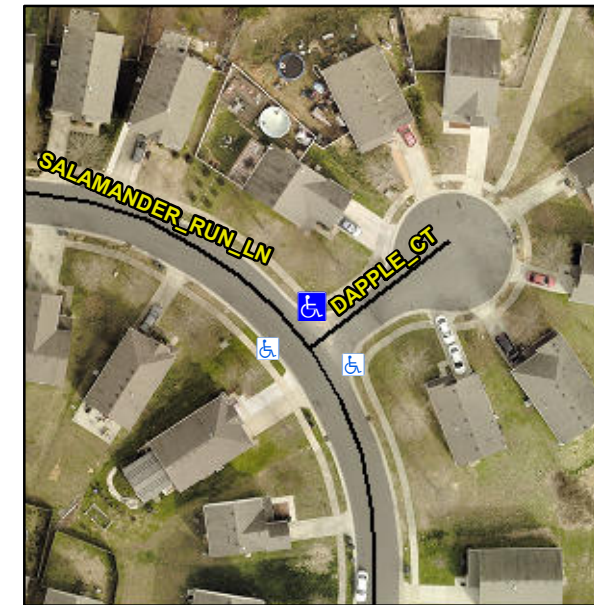
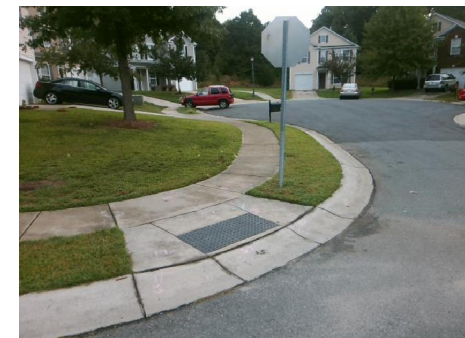
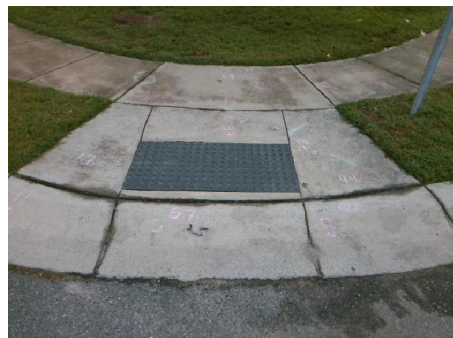
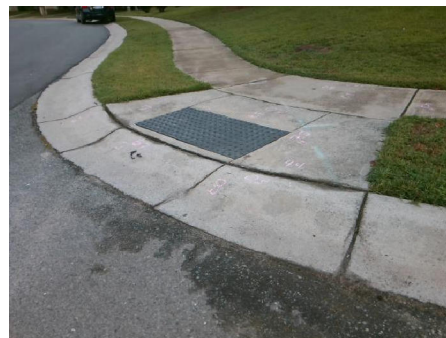
Not Found, R304.2.1, R305.2, R302.7, R302.7.2

Compliance	Description	Data	Compliance	Description	Data
N/A	Ramp Length (in)	52.0	Yes	BlendTrans Slope (%)	3.7
Yes	Ramp Width (in)	48.0	Yes	BlendTrans XSlope (%)	0.7
N/A	Flare Type LT	Sloped	N/A	Flare Type RT	Sloped
N/A	Flare Slope LT (%)	1.7	N/A	Flare Slope RT (%)	4.4
N/A	Flare Traversable LT?	No	N/A	Flare Traversable RT?	No
No	Landing Length (in)	47.0	Yes	DWS Provided?	Yes
Yes	Landing Width (in)	63.0	Yes	DWS Contrast?	Yes
Yes	Landing Slope (%)	0.8	Yes	DWS Length (in)	24.0
Yes	Landing X Slope (%)	0.9	Yes	DWS Full Width?	Yes
N/A	Landing Curb? (Y/N)	No	No	DWS Offset (in)	3.0
N/A	Shared Landing?	No			
No	Gutter Ponding?	Yes	Yes	Gutter Slope (%)	3.2
No	Gutter Lip Ht (in)	0.3	Yes	Gutter X Slope (%)	1.2
N/A	Painted X Walk1?	No	N/A	Painted X Walk2?	No
	X Walk 1 Direction	To SW		X Walk 2 Direction	To SE
	X Walk 1 Width (in)	N/A		X Walk 2 Width (in)	N/A
	X Walk 1 Slope (%)	3.3		X Walk 2 Slope (%)	0.7
	X Walk 1 X Slope (%)	1.1		X Walk 2 X Slope (%)	0.5

N/A	Ramp inside XWalk1?	N/A	N/A	Ramp inside XWalk2?	N/A
	Road Slope (%)	1.5		Clear Space?	Yes
	Road X Slope (%)	0.7	N/A	Clear Space to XWalk (in)	N/A
Yes	Any Obstructions?	No	Yes	Storm Grate/Utility Hazard?	No
	Obstruction Type			Storm Grate/Utility Type	
		N/A			N/A
			Yes	Surface Condition? (G/P)	Good
			No	Curb Slope (%)	27.3

Remove & Replace Curb Ramp With Two New Directional Ramps or Equivalent.
