Access Compliance Report

Public Rights-of-Way

(Curb Ramps)

Intersection ID: 47417	Main Street: SHOPTON_RD	Cross Street: KIRKWYND_COMMONS_DR	Location: NW
ADA ID: 94F60FE6AA8B	Ramp Type: PerpDiag	Initial Pass/Fail: Fail	Overall Compliance: No
Severity Score: 26.25			
Codes/Mitigation Info/Possible Solution		Field Measurements/Component Compliance

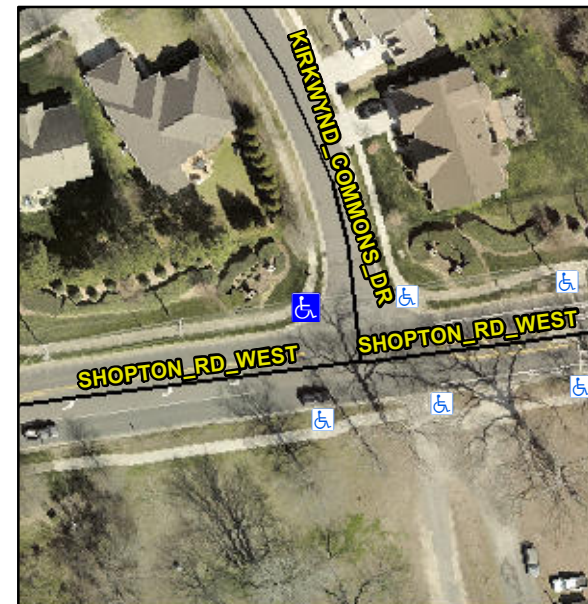
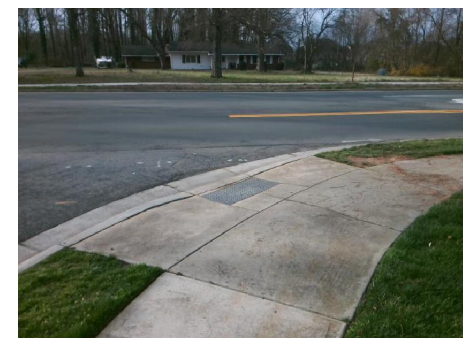
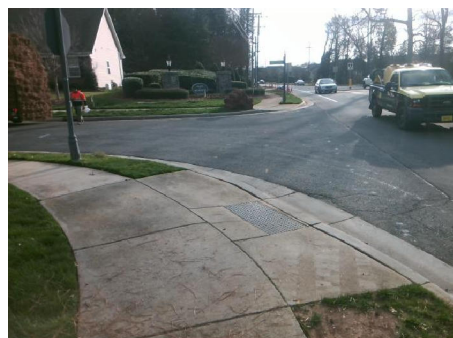
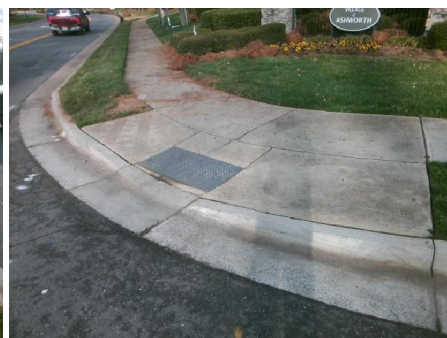
Not Found, R304.2.2, R304.5.3

Compliance	Description	Data	Compliance	Description	Data
N/A	Ramp Length (in)	48.0	No	Ramp Slope (%)	13.4
Yes	Ramp Width (in)	48.0	No	Ramp XSlope (%)	3.0
N/A	Flare Type LT	N/A	N/A	Flare Type RT	N/A
N/A	Flare Slope LT (%)	N/A	N/A	Flare Slope RT (%)	N/A
N/A	Flare Traversable LT?	N/A	N/A	Flare Traversable RT?	N/A
N/A	Landing Length (in)	N/A	N/A	DWS Provided?	N/A
N/A	Landing Width (in)	N/A	N/A	DWS Contrast?	N/A
N/A	Landing Slope (%)	N/A	N/A	DWS Length (in)	N/A
N/A	Landing X Slope (%)	N/A	N/A	DWS Full Width?	N/A
N/A	Landing Curb? (Y/N)	N/A	N/A	DWS Offset (in)	N/A
N/A	Shared Landing?	N/A			
N/A	Gutter Ponding?	N/A	N/A	Gutter Slope (%)	N/A
N/A	Gutter Lip Ht (in)	N/A	N/A	Gutter X Slope (%)	N/A
N/A	Painted X Walk1?	No	N/A	Painted X Walk2?	No
	X Walk 1 Direction	To S		X Walk 2 Direction	To E
N/A	X Walk 1 Width (in)	N/A	N/A	X Walk 2 Width (in)	N/A
	X Walk 1 Slope (%)	0.6		X Walk 2 Slope (%)	2.2
	X Walk 1 X Slope (%)	2.4		X Walk 2 X Slope (%)	0.4

N/A	Ramp inside XWalk1?	N/A	N/A	Ramp inside XWalk2?	N/A
	Road Slope (%)	2.0	N/A	Clear Space?	N/A
	Road X Slope (%)	3.1	N/A	Clear Space to XWalk (in)	N/A
N/A	Any Obstructions?	N/A	N/A	Storm Grate/Utility Hazard?	N/A
	Obstruction Type			Storm Grate/Utility Type	
		N/A			N/A
		Yes		Surface Condition? (G/P)	Good

Remove & Replace Curb Ramp With Two New Directional Ramps or Equivalent.
