# Access Compliance Report

## Public Rights-of-Way

Intersection ID: 9734	Main Street: FREEDOM_DR	Cross Street: S_I-85_HY	Location: SE
ADA ID: 95079EAB4096	Ramp Type: Perp	Initial Pass/Fail: Fail	Overall Compliance: No
			Severity Score: 21.25

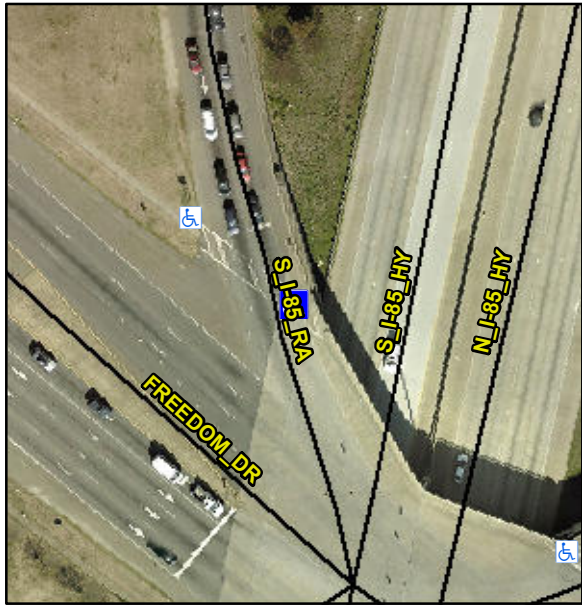
Possible Solutions:		Compliance	Description	Data	Compliance	Description	Data
	Remove & Replace Entire Ramp.		N/A	Ramp Length (in)	85.5	No	Ramp Slope (%)	10.3
			No	Ramp Width (in)	46.0	Yes	Ramp XSlope (%)	0.9
			N/A	Flare Type LT	N/A	N/A	Flare Type RT	N/A
			N/A	Flare Slope LT (%)	N/A	N/A	Flare Slope RT (%)	N/A
			N/A	Flare Traversable LT?	N/A	N/A	Flare Traversable RT?	N/A
			N/A	Landing Length (in)	N/A	N/A	DWS Provided?	N/A
			N/A	Landing Width (in)	N/A	N/A	DWS Contrast?	N/A
			N/A	Landing Slope (%)	N/A	N/A	DWS Length (in)	N/A
			N/A	Landing X Slope (%)	N/A	N/A	DWS Full Width?	N/A
<p>Surveyor Notes:</p> <p>N/A</p> <p>PROW/ADA:</p> <p>R304.5.1, R304.2.2</p>			N/A	Landing Curb? (Y/N)	N/A	N/A	DWS Offset (in)	N/A
			N/A	Shared Landing?	N/A			
			N/A	Gutter Ponding?	N/A	N/A	Gutter Slope (%)	N/A
			N/A	Gutter Lip Ht (in)	N/A	N/A	Gutter X Slope (%)	N/A

N/A	Painted X Walk1?	Yes	N/A	Painted X Walk2?	N/A
				X Walk 1 Direction	To NW		X Walk 2 Direction	N/A
			N/A	X Walk 1 Width (in)	135.0	N/A	X Walk 2 Width (in)	N/A
				X Walk 1 Slope (%)	1.1		X Walk 2 Slope (%)	N/A
				X Walk 1 X Slope (%)	1.0		X Walk 2 X Slope (%)	N/A
			N/A	Ramp inside XWalk1?	Yes	N/A	Ramp inside XWalk2?	N/A
<p>Total Cost:</p> <p>\$ 1850.00</p>				Road Slope (%)	N/A	N/A	Clear Space?	N/A
				Road X Slope (%)	N/A	N/A	Clear Space to XWalk (in)	N/A
			N/A	Any Obstructions?	N/A	N/A	Storm Grate/Utility Hazard?	N/A
				Obstruction Type			Storm Grate/Utility Type	
					N/A			N/A
						Yes	Surface Condition? (G/P)	Good
