Access Compliance Report

Public Rights-of-Way

(Curb Ramps)

Intersection ID: 11878	Main Street: MIMOSA_AV	Cross Street: THE_PLAZA	Location: NW
ADA ID: 9516E232E007	Ramp Type: Perp	Initial Pass/Fail: Fail	Overall Compliance: No
			Severity Score: 21.25

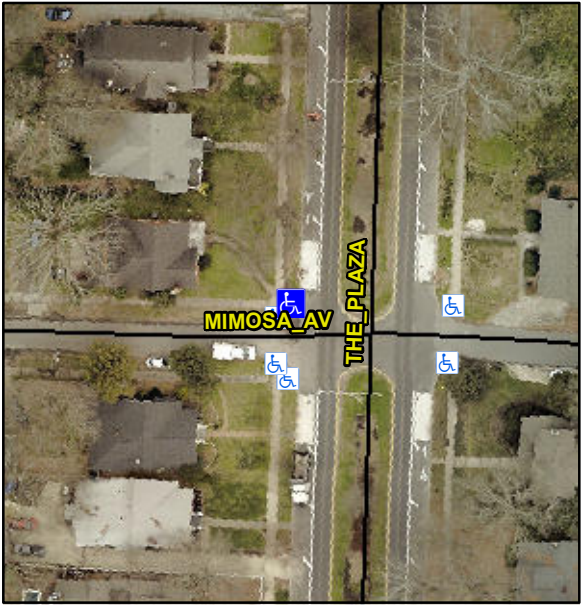
Possible Solutions:		Compliance	Description	Data
	Remove & Replace Entire Ramp.		No	Ramp Length (in)	90.5
			No	Ramp Width (in)	43.0
			N/A	Flare Type LT	N/A
			N/A	Flare Slope LT (%)	N/A
			N/A	Flare Traversable LT?	N/A
			N/A	Landing Length (in)	N/A
			N/A	Landing Width (in)	N/A
			N/A	Landing Slope (%)	N/A
			N/A	Landing X Slope (%)	N/A
<p>Surveyor Notes:</p> <p>N/A</p> <p>PROW/ADA:</p> <p>R304.5.1, R304.2.2</p>			N/A	Flare Type RT	N/A
			N/A	Flare Slope RT (%)	N/A
			N/A	Flare Traversable RT?	N/A
			N/A	DWS Provided?	N/A
			N/A	DWS Contrast?	N/A
			N/A	DWS Length (in)	N/A
			N/A	DWS Full Width?	N/A
			N/A	DWS Offset (in)	N/A
			N/A	Shared Landing?	N/A
			N/A	Gutter Ponding?	N/A
			N/A	Gutter Lip Ht (in)	N/A
			N/A	Painted X Walk1?	No
				X Walk 1 Direction	To E
			N/A	X Walk 1 Width (in)	N/A
				X Walk 1 Slope (%)	5.0
				X Walk 1 X Slope (%)	0.3

N/A	Ramp inside XWalk1?	N/A
			N/A	Road Slope (%)	N/A
			N/A	Road X Slope (%)	N/A
			N/A	Any Obstructions?	N/A
				Obstruction Type	
			N/A		
			N/A		N/A
			Yes	Surface Condition? (G/P)	Good

Total Cost: \$ 1850.00
