Good

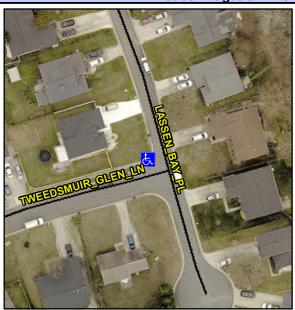
PROW/ADA:

Total Cost: \$ 3200.00

Compliance Description		Data	Compl	iance	Description
N/A	Ramp Length (in)	44.5	Yes	Blend	dTrans Slope (%)
No	Ramp Width (in)	46.0	Yes	Blend	dTrans XSlope (%)
N/A	Flare Type LT	N/A	N/A	Flare	Type RT
N/A	Flare Slope LT (%)	N/A	N/A	Flare	Slope RT (%)
N/A	Flare Traversable LT?	N/A	N/A	Flare	Traversable RT?
N/A	Landing Length (in)	N/A	N/A	DWS	Provided?
N/A	Landing Width (in)	N/A	N/A	DWS	Contrast?
N/A	Landing Slope (%)	N/A	N/A	DWS	Length (in)
N/A	Landing X Slope (%)	N/A	N/A	DWS	Full Width?
N/A	Landing Curb? (Y/N)	N/A	N/A	DWS	Offset (in)
N/A	Shared Landing?	N/A			
N/A	Gutter Ponding?	N/A	N/A	Gutte	er Slope (%)
N/A	Gutter Lip Ht (in)	N/A	N/A	Gutte	er X Slope (%)
N/A	Painted X Walk1?	No	N/A	Paint	ed X Walk2?
	X Walk 1 Direction	То Е		X Wa	lk 2 Direction
	X Walk 1 Width (in)	N/A		X Wa	ılk 2 Width (in)
	X Walk 1 Slope (%)	0.7		X Wa	ılk 2 Slope (%)
	X Walk 1 X Slope (%)	6.6		X Wa	ılk 2 X Slope (%)
N/A	Ramp inside XWalk1?	N/A	N/A	Ram	p inside XWalk2?

Possible Solutions:
