Access Compliance Report Public Rights-of-Way (Curb Ramps)

Intersection ID: 46206	Main Street: LOROPETALUM_RD	Cross Street: SNOWBELL_CT	Location: SW
ADA ID: 952CE742E3A3	Ramp Type: BlendTrans1	Initial Pass/Fail: Pass	Overall Compliance: No Severity Score: 20

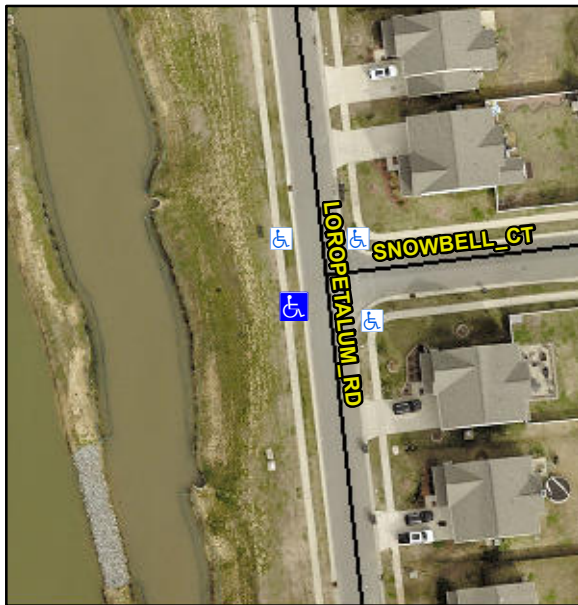
Not Found, R304.2.1, R305.2, R302.7, R302.7.2, R304.5.4

Compliance	Description	Data	Compliance	Description	Data
N/A	Ramp Length (in)	70.5	Yes	BlendTrans Slope (%)	4.2
Yes	Ramp Width (in)	48.0	Yes	BlendTrans XSlope (%)	0.1
N/A	Flare Type LT	Sloped	N/A	Flare Type RT	Sloped
N/A	Flare Slope LT (%)	1.3	N/A	Flare Slope RT (%)	6.0
N/A	Flare Traversable LT?	No	N/A	Flare Traversable RT?	No
No	Landing Length (in)	46.5	Yes	DWS Provided?	Yes
Yes	Landing Width (in)	48.0	Yes	DWS Contrast?	Yes
Yes	Landing Slope (%)	1.5	Yes	DWS Length (in)	24.0
Yes	Landing X Slope (%)	0.0	Yes	DWS Full Width?	Yes
N/A	Landing Curb? (Y/N)	No	No	DWS Offset (in)	5.0
N/A	Shared Landing?	No			
No	Gutter Ponding?	Yes	No	Gutter Slope (%)	9.0
No	Gutter Lip Ht (in)	2.0	Yes	Gutter X Slope (%)	1.1
N/A	Painted X Walk1?	No	N/A	Painted X Walk2?	N/A
	X Walk 1 Direction	To E		X Walk 2 Direction	N/A
	X Walk 1 Width (in)	N/A		X Walk 2 Width (in)	N/A
	X Walk 1 Slope (%)	3.4		X Walk 2 Slope (%)	N/A
	X Walk 1 X Slope (%)	0.3		X Walk 2 X Slope (%)	N/A

N/A	Ramp inside XWalk1?	N/A	N/A	Ramp inside XWalk2?	N/A
	Road Slope (%)	0.3		Clear Space?	Yes
	Road X Slope (%)	3.4	N/A	Clear Space to XWalk (in)	N/A
Yes	Any Obstructions?	No	Yes	Storm Grate/Utility Hazard?	No
	Obstruction Type			Storm Grate/Utility Type	
		N/A			N/A
Yes	Surface Condition? (G/P)		Good		
No	Curb Slope (%)		11.4

Remove & Replace Curb Ramp With Two New Directional Ramps or Equivalent. Remove & Replace Gutter.
