Access Compliance Report

Public Rights-of-Way

(Curb Ramps)

Intersection ID: 10029616	Main Street: KING_ARTHUR_DR	Cross Street: N/A	Location:	NE
ADA ID: 9530BDC0716A	Ramp Type: Perp	Initial Pass/Fail: Fail	Overall Compliance: No	Severity Score: 30
Codes/Mitigation Info/Possible Solution		Field Measurements/Component Compliance

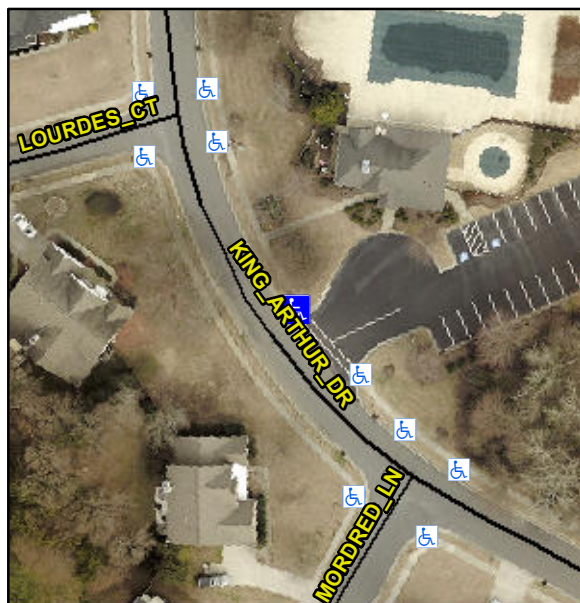
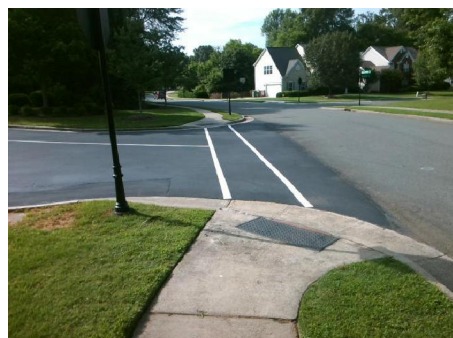
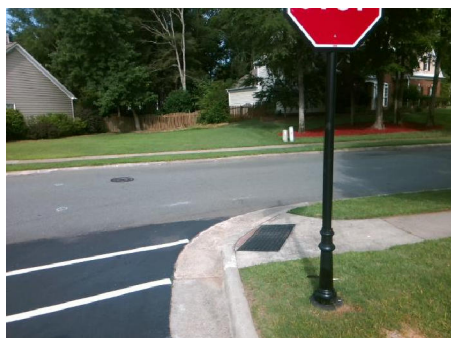
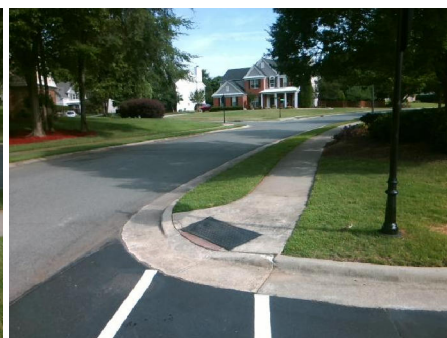
Not Found, R304.5.1, R304.2.2

Compliance	Description	Data	Compliance	Description	Data
N/A	Ramp Length (in)	103.0	No	Ramp Slope (%)	9.8
No	Ramp Width (in)	34.0	Yes	Ramp XSlope (%)	0.3
N/A	Flare Type LT	N/A	N/A	Flare Type RT	N/A
N/A	Flare Slope LT (%)	N/A	N/A	Flare Slope RT (%)	N/A
N/A	Flare Traversable LT?	N/A	N/A	Flare Traversable RT?	N/A
N/A	Landing Length (in)	N/A	N/A	DWS Provided?	N/A
N/A	Landing Width (in)	N/A	N/A	DWS Contrast?	N/A
N/A	Landing Slope (%)	N/A	N/A	DWS Length (in)	N/A
N/A	Landing X Slope (%)	N/A	N/A	DWS Full Width?	N/A
N/A	Landing Curb? (Y/N)	N/A	N/A	DWS Offset (in)	N/A
N/A	Shared Landing?	N/A			
N/A	Gutter Ponding?	N/A	N/A	Gutter Slope (%)	N/A
N/A	Gutter Lip Ht (in)	N/A	N/A	Gutter X Slope (%)	N/A
N/A	Painted X Walk1?	Yes	N/A	Painted X Walk2?	N/A
	X Walk 1 Direction	To SE		X Walk 2 Direction	N/A
N/A	X Walk 1 Width (in)	44.0	N/A	X Walk 2 Width (in)	N/A
	X Walk 1 Slope (%)	0.6		X Walk 2 Slope (%)	N/A
	X Walk 1 X Slope (%)	3.0		X Walk 2 X Slope (%)	N/A

N/A	Ramp inside XWalk1?	Yes	N/A	Ramp inside XWalk2?	N/A
	Road Slope (%)	N/A	N/A	Clear Space?	N/A
	Road X Slope (%)	N/A	N/A	Clear Space to XWalk (in)	N/A
N/A	Any Obstructions?	N/A	N/A	Storm Grate/Utility Hazard?	N/A
	Obstruction Type			Storm Grate/Utility Type	
		N/A			N/A
		Yes		Surface Condition? (G/P)	Good

Remove & Replace Entire Ramp.
