# Access Compliance Report

## Public Rights-of-Way

### (Curb Ramps)

Intersection ID: 19683	Main Street: CONGRESS_ST	Cross Street: CARNEGIE_BV	Location: NE
ADA ID: 9531F1136D65	Ramp Type: PerpDiag	Initial Pass/Fail: Fail	Overall Compliance: No
		Severity Score: 12.5

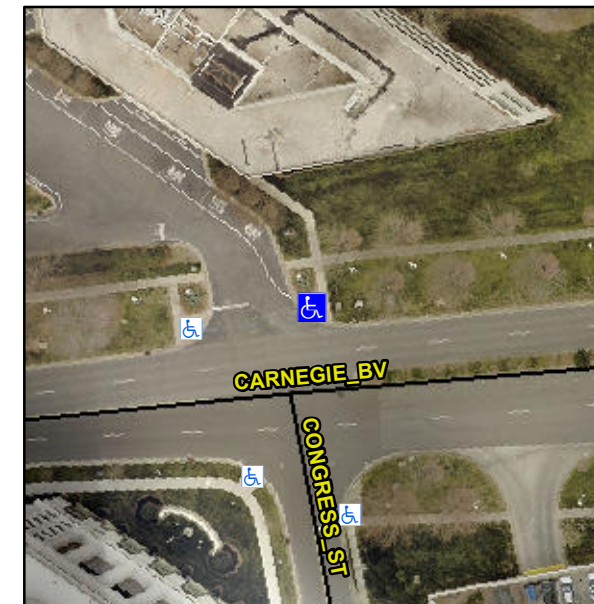
**Not Found, R304.5.3**

Compliance	Description	Data	Compliance	Description	Data
N/A	Ramp Length (in)	72.0	Yes	Ramp Slope (%)	5.1
Yes	Ramp Width (in)	58.0	No	Ramp XSlope (%)	5.5
N/A	Flare Type LT	N/A	N/A	Flare Type RT	N/A
N/A	Flare Slope LT (%)	N/A	N/A	Flare Slope RT (%)	N/A
N/A	Flare Traversable LT?	N/A	N/A	Flare Traversable RT?	N/A
N/A	Landing Length (in)	N/A	N/A	DWS Provided?	N/A
N/A	Landing Width (in)	N/A	N/A	DWS Contrast?	N/A
N/A	Landing Slope (%)	N/A	N/A	DWS Length (in)	N/A
N/A	Landing X Slope (%)	N/A	N/A	DWS Full Width?	N/A
N/A	Landing Curb? (Y/N)	N/A	N/A	DWS Offset (in)	N/A
N/A	Shared Landing?	N/A			
N/A	Gutter Ponding?	N/A	N/A	Gutter Slope (%)	N/A
N/A	Gutter Lip Ht (in)	N/A	N/A	Gutter X Slope (%)	N/A
N/A	Painted X Walk1?	No	N/A	Painted X Walk2?	No
	X Walk 1 Direction	To W		X Walk 2 Direction	To S
N/A	X Walk 1 Width (in)	N/A	N/A	X Walk 2 Width (in)	N/A
	X Walk 1 Slope (%)	2.4		X Walk 2 Slope (%)	6.3
	X Walk 1 X Slope (%)	1.4		X Walk 2 X Slope (%)	1.4

N/A	Ramp inside XWalk1?	N/A	N/A	Ramp inside XWalk2?	N/A
	Road Slope (%)	0.8	N/A	Clear Space?	N/A
	Road X Slope (%)	2.5	N/A	Clear Space to XWalk (in)	N/A
N/A	Any Obstructions?	N/A	N/A	Storm Grate/Utility Hazard?	N/A
	Obstruction Type			Storm Grate/Utility Type	
		N/A			N/A
			Yes	Surface Condition? (G/P)	Good

**Remove & Replace Curb Ramp With Two New Directional Ramps or Equivalent.**

Total Cost: \$ 3200.00
