Access Compliance Report

Public Rights-of-Way

(Curb Ramps)

Intersection ID: 50867	Main Street: REAMES_RD	Cross Street: BROOKLINE_RIDGE_DR	Location: SW
ADA ID: 9533A2655783	Ramp Type: Perp	Initial Pass/Fail: Fail	Overall Compliance: No
Severity Score: 21.25			
Codes/Mitigation Info/Possible Solution		Field Measurements/Component Compliance

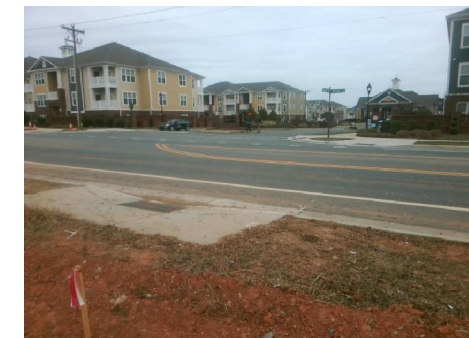
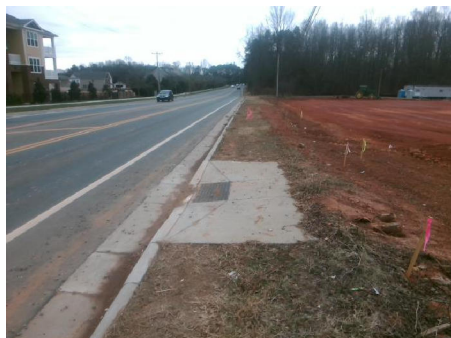
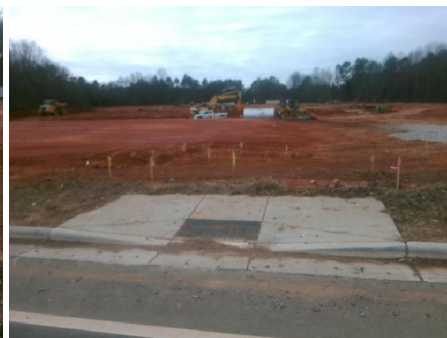
Not Found, R304.5.1, R304.2.2

Compliance	Description	Data	Compliance	Description	Data
N/A	Ramp Length (in)	73.0	No	Ramp Slope (%)	9.4
No	Ramp Width (in)	46.5	Yes	Ramp XSlope (%)	0.8
N/A	Flare Type LT	N/A	N/A	Flare Type RT	N/A
N/A	Flare Slope LT (%)	N/A	N/A	Flare Slope RT (%)	N/A
N/A	Flare Traversable LT?	N/A	N/A	Flare Traversable RT?	N/A
N/A	Landing Length (in)	N/A	N/A	DWS Provided?	N/A
N/A	Landing Width (in)	N/A	N/A	DWS Contrast?	N/A
N/A	Landing Slope (%)	N/A	N/A	DWS Length (in)	N/A
N/A	Landing X Slope (%)	N/A	N/A	DWS Full Width?	N/A
N/A	Landing Curb? (Y/N)	N/A	N/A	DWS Offset (in)	N/A
N/A	Shared Landing?	N/A			
N/A	Gutter Ponding?	N/A	N/A	Gutter Slope (%)	N/A
N/A	Gutter Lip Ht (in)	N/A	N/A	Gutter X Slope (%)	N/A
N/A	Painted X Walk1?	No	N/A	Painted X Walk2?	N/A
	X Walk 1 Direction	To E		X Walk 2 Direction	N/A
N/A	X Walk 1 Width (in)	N/A	N/A	X Walk 2 Width (in)	N/A
	X Walk 1 Slope (%)	2.5		X Walk 2 Slope (%)	N/A
	X Walk 1 X Slope (%)	0.5		X Walk 2 X Slope (%)	N/A

N/A	Ramp inside XWalk1?	N/A	N/A	Ramp inside XWalk2?	N/A
	Road Slope (%)	N/A	N/A	Clear Space?	N/A
	Road X Slope (%)	N/A	N/A	Clear Space to XWalk (in)	N/A
N/A	Any Obstructions?	N/A	N/A	Storm Grate/Utility Hazard?	N/A
	Obstruction Type			Storm Grate/Utility Type	
		N/A			N/A
			Yes	Surface Condition? (G/P)	Good

Remove & Replace Entire Ramp.
