# Access Compliance Report

## Public Rights-of-Way

### (Curb Ramps)

Intersection ID: 11635	Main Street: BELFAST_DR	Cross Street: DICKENS_AV	Location:	N
ADA ID: 953B341CE6FD	Ramp Type: Perp	Initial Pass/Fail: Fail	Overall Compliance: No	Severity Score: 10
Codes/Mitigation Info/Possible Solution		Field Measurements/Component Compliance

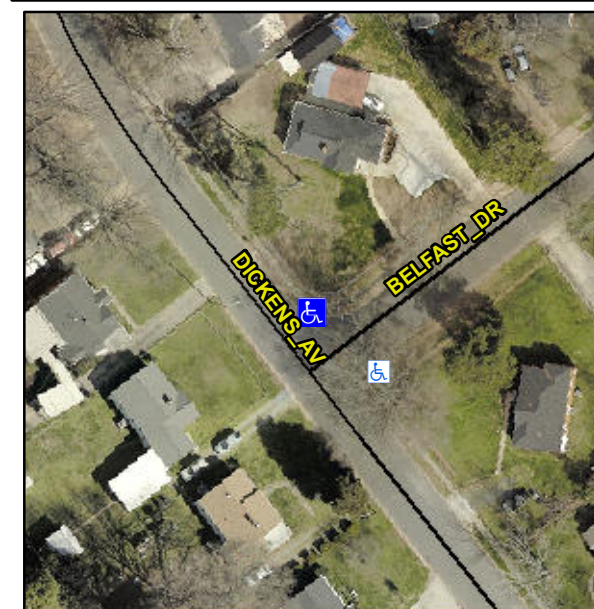
**Not Found, R304.5.1, R304.5.3**

Compliance	Description	Data	Compliance	Description	Data
N/A	Ramp Length (in)	67.0	Yes	Ramp Slope (%)	5.1
No	Ramp Width (in)	45.0	No	Ramp XSlope (%)	2.1
N/A	Flare Type LT	N/A	N/A	Flare Type RT	N/A
N/A	Flare Slope LT (%)	N/A	N/A	Flare Slope RT (%)	N/A
N/A	Flare Traversable LT?	N/A	N/A	Flare Traversable RT?	N/A
N/A	Landing Length (in)	N/A	N/A	DWS Provided?	N/A
N/A	Landing Width (in)	N/A	N/A	DWS Contrast?	N/A
N/A	Landing Slope (%)	N/A	N/A	DWS Length (in)	N/A
N/A	Landing X Slope (%)	N/A	N/A	DWS Full Width?	N/A
N/A	Landing Curb? (Y/N)	N/A	N/A	DWS Offset (in)	N/A
N/A	Shared Landing?	N/A			
N/A	Gutter Ponding?	N/A	N/A	Gutter Slope (%)	N/A
N/A	Gutter Lip Ht (in)	N/A	N/A	Gutter X Slope (%)	N/A
N/A	Painted X Walk1?	No	N/A	Painted X Walk2?	N/A
	X Walk 1 Direction	To SE		X Walk 2 Direction	N/A
N/A	X Walk 1 Width (in)	N/A	N/A	X Walk 2 Width (in)	N/A
	X Walk 1 Slope (%)	1.0		X Walk 2 Slope (%)	N/A
	X Walk 1 X Slope (%)	2.4		X Walk 2 X Slope (%)	N/A

N/A	Ramp inside XWalk1?	N/A	N/A	Ramp inside XWalk2?	N/A
	Road Slope (%)	N/A	N/A	Clear Space?	N/A
	Road X Slope (%)	N/A	N/A	Clear Space to XWalk (in)	N/A
N/A	Any Obstructions?	N/A	N/A	Storm Grate/Utility Hazard?	N/A
	Obstruction Type			Storm Grate/Utility Type	
		N/A			N/A
			Yes	Surface Condition? (G/P)	Good

**Remove & Replace Entire Ramp.**

Total Cost: \$ 1850.00
