Access Compliance Report

Public Rights-of-Way

(Curb Ramps)

Intersection ID: 12126	Main Street: KIMMERLY_GLEN_LN	Cross Street: N_SHARON_AMITY_RD	Location: E
ADA ID: 953BDA38300A	Ramp Type: PerpDiag	Initial Pass/Fail: Fail	Overall Compliance: No
Severity Score: 26.25			
Codes/Mitigation Info/Possible Solution		Field Measurements/Component Compliance

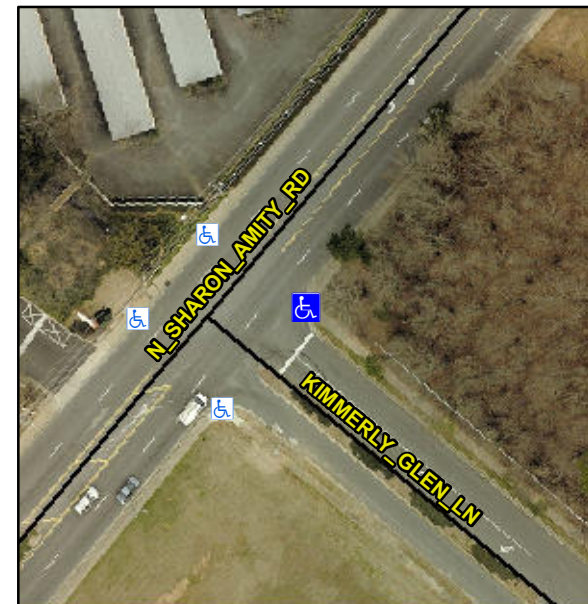
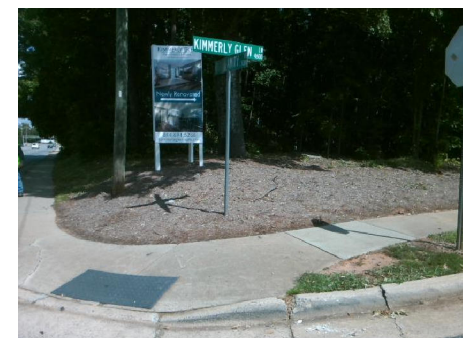
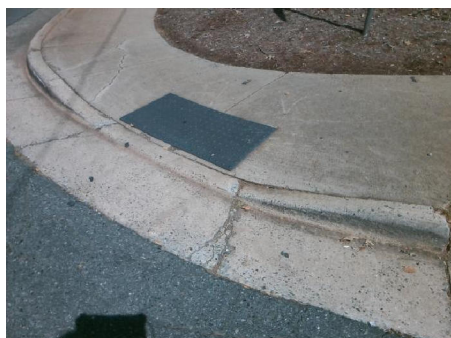
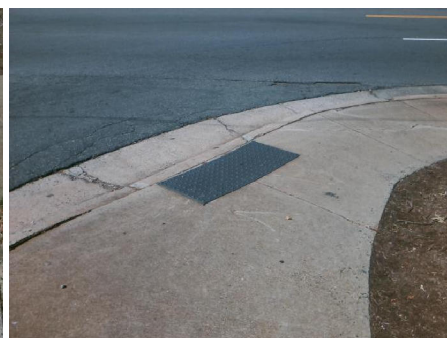
Not Found, R304.2.2, R304.5.3

Compliance	Description	Data	Compliance	Description	Data
N/A	Ramp Length (in)	60.5	No	Ramp Slope (%)	12.2
Yes	Ramp Width (in)	53.0	No	Ramp XSlope (%)	2.4
N/A	Flare Type LT	N/A	N/A	Flare Type RT	N/A
N/A	Flare Slope LT (%)	N/A	N/A	Flare Slope RT (%)	N/A
N/A	Flare Traversable LT?	N/A	N/A	Flare Traversable RT?	N/A
N/A	Landing Length (in)	N/A	N/A	DWS Provided?	N/A
N/A	Landing Width (in)	N/A	N/A	DWS Contrast?	N/A
N/A	Landing Slope (%)	N/A	N/A	DWS Length (in)	N/A
N/A	Landing X Slope (%)	N/A	N/A	DWS Full Width?	N/A
N/A	Landing Curb? (Y/N)	N/A	N/A	DWS Offset (in)	N/A
N/A	Shared Landing?	N/A			
N/A	Gutter Ponding?	N/A	N/A	Gutter Slope (%)	N/A
N/A	Gutter Lip Ht (in)	1.5	N/A	Gutter X Slope (%)	N/A
N/A	Painted X Walk1?	No	N/A	Painted X Walk2?	No
	X Walk 1 Direction	To NW		X Walk 2 Direction	To SW
N/A	X Walk 1 Width (in)	N/A	N/A	X Walk 2 Width (in)	N/A
	X Walk 1 Slope (%)	0.8		X Walk 2 Slope (%)	1.6
	X Walk 1 X Slope (%)	0.9		X Walk 2 X Slope (%)	5.8

N/A	Ramp inside XWalk1?	N/A	N/A	Ramp inside XWalk2?	N/A
	Road Slope (%)	4.7	N/A	Clear Space?	N/A
	Road X Slope (%)	3.7	N/A	Clear Space to XWalk (in)	N/A
N/A	Any Obstructions?	N/A	N/A	Storm Grate/Utility Hazard?	N/A
	Obstruction Type			Storm Grate/Utility Type	
		N/A			N/A
			Yes	Surface Condition? (G/P)	Good

Remove & Replace Curb Ramp With Two New Directional Ramps or Equivalent.

Total Cost: \$ **3200.00**
