Access Compliance Report

Public Rights-of-Way

(Curb Ramps)

Intersection ID: 7036	Main Street: BEATTIES_FORD_RD	Cross Street: MCALLISTER_DR	Location: NE
ADA ID: 953EEF02BA9E	Ramp Type: Para	Initial Pass/Fail: Fail	Overall Compliance: No
Codes/Mitigation Info/Possible Solution		Field Measurements/Component Compliance	
Severity Score: 1.25

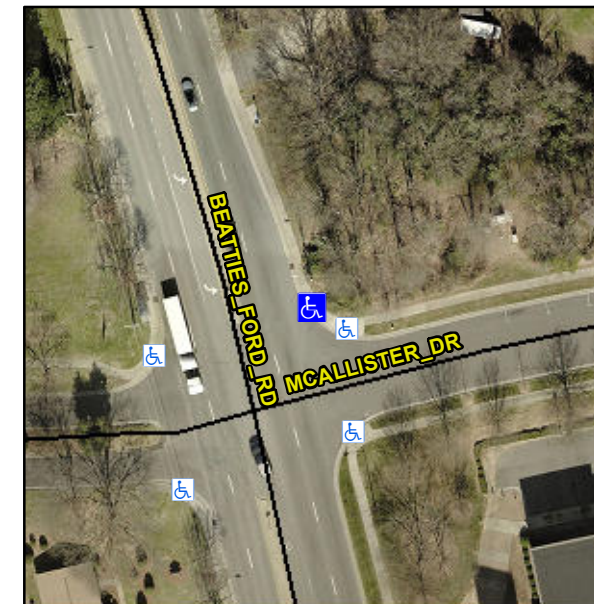
LT RP < 5%

Compliance	Description	Data	Compliance	Description	Data
N/A	Ramp Length LT (in)	65.0	N/A	Ramp Length RT (in)	48.5
Yes	Ramp Width LT (in)	60.0	Yes	Ramp Width RT (in)	60.0
Yes	Ramp Slope LT (%)	3.3	Yes	Ramp Slope RT (%)	7.9
Yes	Ramp XSlope LT (%)	0.2	No	Ramp XSlope RT (%)	2.3
N/A	Landing Length (in)	N/A	N/A	DWS Provided?	N/A
N/A	Landing Width (in)	N/A	N/A	DWS Contrast?	N/A
N/A	Landing Slope (%)	N/A	N/A	DWS Length (in)	N/A
N/A	Landing X Slope (%)	N/A	N/A	DWS Full Width?	N/A
N/A	Landing Curb? (Y/N)	N/A	N/A	DWS Offset (in)	N/A
N/A	Shared Landing?	N/A			
N/A	Gutter Ponding?	N/A	N/A	Gutter Slope (%)	N/A
N/A	Gutter Lip Ht (in)	N/A	N/A	Gutter X Slope (%)	N/A
N/A	Painted X Walk1?	No	N/A	Painted X Walk2?	N/A
	X Walk 1 Direction	To W		X Walk 2 Direction	N/A
N/A	X Walk 1 Width (in)	N/A	N/A	X Walk 2 Width (in)	N/A
	X Walk 1 Slope (%)	0.8		X Walk 2 Slope (%)	N/A
	X Walk 1 X Slope (%)	2.1		X Walk 2 X Slope (%)	N/A
N/A	Ramp inside XWalk1?	N/A	N/A	Ramp inside XWalk2?	N/A

Road Slope (%)	N/A	N/A	Clear Space?	N/A
	Road X Slope (%)	N/A	N/A	Clear Space to XWalk (in)	N/A
N/A	Any Obstructions?	N/A	N/A	Storm Grate/Utility Hazard?	N/A
	Obstruction Type			Storm Grate/Utility Type	
		N/A			N/A
			Yes	Surface Condition? (G/P)	Good
			N/A	Curb Slope (%)	10.7

Possible Solutions:

Remove & Replace Entire Ramp.

PROW/ADA:

R304.5.3
