# Access Compliance Report

## Public Rights-of-Way

### (Curb Ramps)

| Intersection ID: 10132 | Main Street: CAMPUS_ST | Cross Street: MILL_RD | Location: SE |

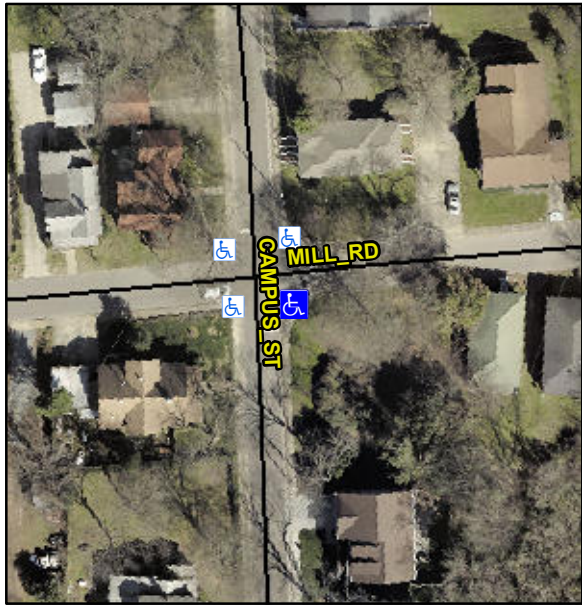
| ADA ID: 95486AAA213D | Ramp Type: PerpDiag | Initial Pass/Fail: Fail | Overall Compliance: No |

| | Remove & Replace Curb Ramp With Two New Directional Ramps or Equivalent. | | N/A | | Ramp Length (in) | | 44.0 | Yes | | Ramp Slope (%) | 7.4 |
| | | | No | | Ramp Width (in) | | 46.0 | No | | Ramp XSlope (%) | 5.4 |

| Not Found, R304.5.1, R304.5.3 | |
