Access Compliance Report

Public Rights-of-Way

(Curb Ramps)

Intersection ID: N/A	Main Street: PROVIDENCE_RD	Cross Street: N/A	Location: SW
ADA ID: 954B86CEC564	Ramp Type: Perp	Initial Pass/Fail: Fail	Overall Compliance: No
Severity Score: 13.75			
Codes/Mitigation Info/Possible Solution		Field Measurements/Component Compliance

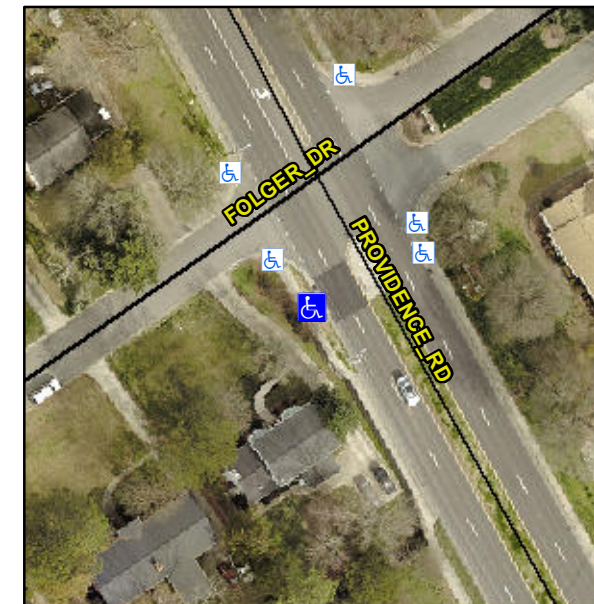
Not Found, R304.2.2

Compliance	Description	Data	Compliance	Description	Data
N/A	Ramp Length (in)	66.0	No	Ramp Slope (%)	11.9
Yes	Ramp Width (in)	72.0	Yes	Ramp XSlope (%)	2.8
N/A	Flare Type LT	N/A	N/A	Flare Type RT	N/A
N/A	Flare Slope LT (%)	N/A	N/A	Flare Slope RT (%)	N/A
N/A	Flare Traversable LT?	N/A	N/A	Flare Traversable RT?	N/A
N/A	Landing Length (in)	N/A	N/A	DWS Provided?	N/A
N/A	Landing Width (in)	N/A	N/A	DWS Contrast?	N/A
N/A	Landing Slope (%)	N/A	N/A	DWS Length (in)	N/A
N/A	Landing X Slope (%)	N/A	N/A	DWS Full Width?	N/A
N/A	Landing Curb? (Y/N)	N/A	N/A	DWS Offset (in)	N/A
N/A	Shared Landing?	N/A			
N/A	Gutter Ponding?	N/A	N/A	Gutter Slope (%)	N/A
N/A	Gutter Lip Ht (in)	N/A	N/A	Gutter X Slope (%)	N/A
N/A	Painted X Walk1?	No	N/A	Painted X Walk2?	N/A
	X Walk 1 Direction	To NE		X Walk 2 Direction	N/A
N/A	X Walk 1 Width (in)	N/A	N/A	X Walk 2 Width (in)	N/A
	X Walk 1 Slope (%)	2.6		X Walk 2 Slope (%)	N/A
	X Walk 1 X Slope (%)	3.0		X Walk 2 X Slope (%)	N/A

Possible Solutions:

Remove & Replace Entire Ramp.
