# Access Compliance Report

## Public Rights-of-Way

### (Curb Ramps)

Intersection ID: 27121	Main Street: ELM_LN	Cross Street: ENDAHVEN_LN	Location: NW
ADA ID: 954F5307EBCF	Ramp Type: Perp	Initial Pass/Fail: Fail	Overall Compliance: No
			Severity Score: 33.75

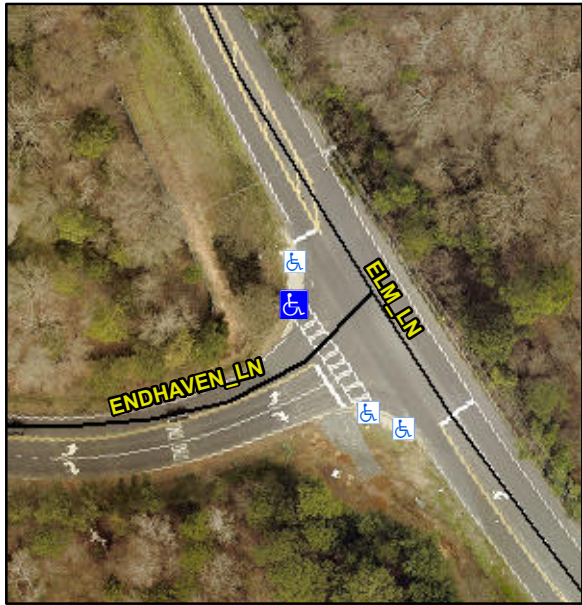
Possible Solutions:		Compliance	Description	Data	Compliance	Description	Data
	Remove & Replace Entire Ramp.		N/A	Ramp Length (in)	26.0	Yes	Ramp Slope (%)	6.9
			No	Ramp Width (in)	47.5	No	Ramp XSlope (%)	10.8
			N/A	Flare Type LT	N/A	N/A	Flare Type RT	N/A
			N/A	Flare Slope LT (%)	N/A	N/A	Flare Slope RT (%)	N/A
			N/A	Flare Traversable LT?	N/A	N/A	Flare Traversable RT?	N/A
			N/A	Landing Length (in)	N/A	N/A	DWS Provided?	N/A
			N/A	Landing Width (in)	N/A	N/A	DWS Contrast?	N/A
			N/A	Landing Slope (%)	N/A	N/A	DWS Length (in)	N/A
			N/A	Landing X Slope (%)	N/A	N/A	DWS Full Width?	N/A
Surveyor Notes:		N/A	N/A	Landing Curb? (Y/N)	N/A	N/A	DWS Offset (in)	N/A
PROW/ADA:		R304.5.1, R304.5.3	N/A	Shared Landing?	N/A			
			N/A	Gutter Ponding?	N/A	N/A	Gutter Slope (%)	N/A
			N/A	Gutter Lip Ht (in)	N/A	N/A	Gutter X Slope (%)	N/A
