Access Compliance Report

Public Rights-of-Way

(Curb Ramps)

Intersection ID: 13787	Main Street: CHARLOTTETOWNE_AV	Cross Street: E_4TH_ST	Location: E
ADA ID: 9553B8433B97	Ramp Type: Perp	Initial Pass/Fail: Fail	Overall Compliance: No
Severity Score: 8.75			
Codes/Mitigation Info/Possible Solution		Field Measurements/Component Compliance

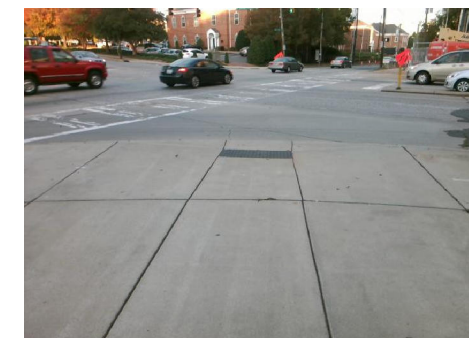
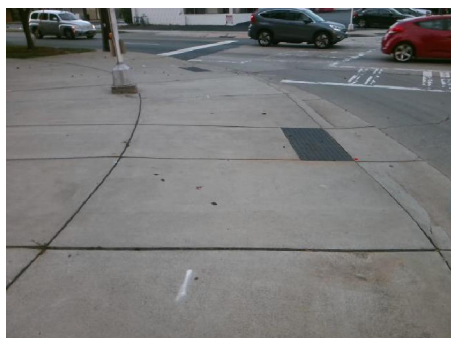
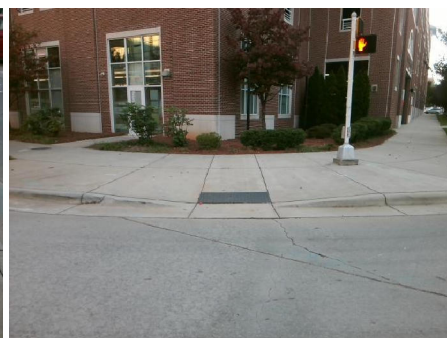
Compliance	Description	Data	Compliance	Description	Data
N/A	Ramp Length (in)	103.0	Yes	Ramp Slope (%)	7.0
No	Ramp Width (in)	47.5	Yes	Ramp XSlope (%)	1.3
N/A	Flare Type LT	N/A	N/A	Flare Type RT	N/A
N/A	Flare Slope LT (%)	N/A	N/A	Flare Slope RT (%)	N/A
N/A	Flare Traversable LT?	N/A	N/A	Flare Traversable RT?	N/A
N/A	Landing Length (in)	N/A	N/A	DWS Provided?	N/A
N/A	Landing Width (in)	N/A	N/A	DWS Contrast?	N/A
N/A	Landing Slope (%)	N/A	N/A	DWS Length (in)	N/A
N/A	Landing X Slope (%)	N/A	N/A	DWS Full Width?	N/A
N/A	Landing Curb? (Y/N)	N/A	N/A	DWS Offset (in)	N/A
N/A	Shared Landing?	N/A			
N/A	Gutter Ponding?	N/A	N/A	Gutter Slope (%)	N/A
N/A	Gutter Lip Ht (in)	N/A	N/A	Gutter X Slope (%)	N/A
N/A	Painted X Walk1?	No	N/A	Painted X Walk2?	N/A
	X Walk 1 Direction	To NW		X Walk 2 Direction	N/A
N/A	X Walk 1 Width (in)	N/A	N/A	X Walk 2 Width (in)	N/A
	X Walk 1 Slope (%)	0.3		X Walk 2 Slope (%)	N/A
	X Walk 1 X Slope (%)	0.2		X Walk 2 X Slope (%)	N/A

N/A	Ramp inside XWalk1?	N/A	N/A	Ramp inside XWalk2?	N/A
	Road Slope (%)	N/A	N/A	Clear Space?	N/A
	Road X Slope (%)	N/A	N/A	Clear Space to XWalk (in)	N/A
N/A	Any Obstructions?	N/A	N/A	Storm Grate/Utility Hazard?	N/A
	Obstruction Type			Storm Grate/Utility Type	
		N/A			N/A
		Yes		Surface Condition? (G/P)	Good

Possible Solutions:

Remove & Replace Entire Ramp.
