# Access Compliance Report

## Public Rights-of-Way

### (Curb Ramps)

Intersection ID: 46494	Main Street: BONNYBRIDGE_CT	Cross Street: BERE_ISLAND_DR	Location: NE
ADA ID: 95540484A898	Ramp Type: BlendTrans1	Initial Pass/Fail: Fail	Overall Compliance: No
Severity Score: 33.75			
Codes/Mitigation Info/Possible Solution		Field Measurements/Component Compliance

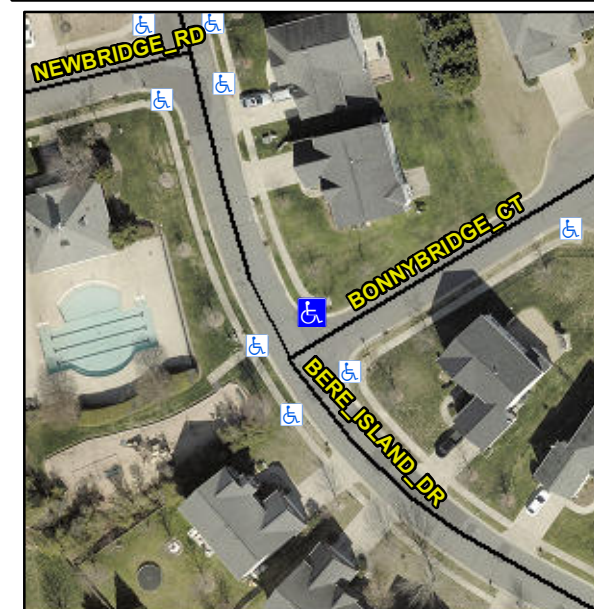
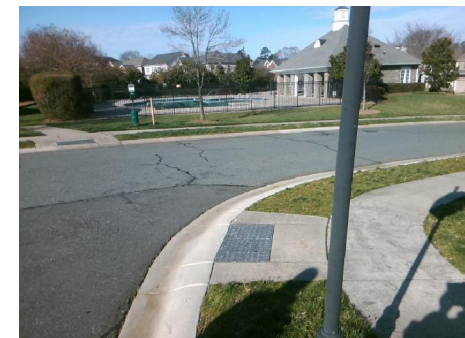
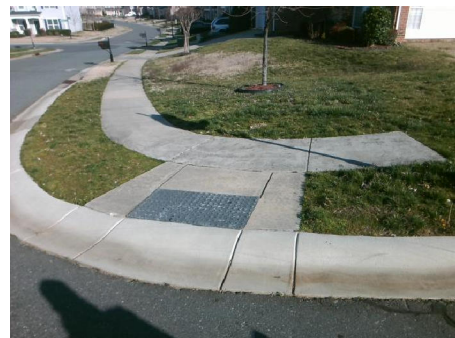
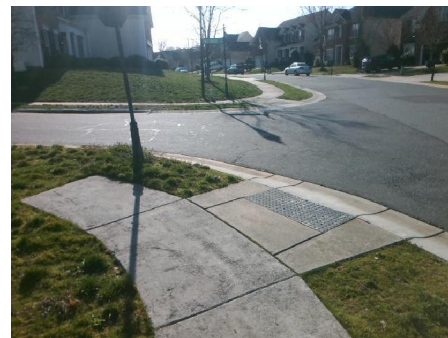
**Not Found, R304.5.1, R304.5.3**

Compliance	Description	Data	Compliance	Description	Data
N/A	Ramp Length (in)	48.0	Yes	BlendTrans Slope (%)	2.2
No	Ramp Width (in)	47.0	No	BlendTrans XSlope (%)	8.0
N/A	Flare Type LT	N/A	N/A	Flare Type RT	N/A
N/A	Flare Slope LT (%)	N/A	N/A	Flare Slope RT (%)	N/A
N/A	Flare Traversable LT?	N/A	N/A	Flare Traversable RT?	N/A
N/A	Landing Length (in)	N/A	N/A	DWS Provided?	N/A
N/A	Landing Width (in)	N/A	N/A	DWS Contrast?	N/A
N/A	Landing Slope (%)	N/A	N/A	DWS Length (in)	N/A
N/A	Landing X Slope (%)	N/A	N/A	DWS Full Width?	N/A
N/A	Landing Curb? (Y/N)	N/A	N/A	DWS Offset (in)	N/A
N/A	Shared Landing?	N/A			
N/A	Gutter Ponding?	N/A	N/A	Gutter Slope (%)	N/A
N/A	Gutter Lip Ht (in)	N/A	N/A	Gutter X Slope (%)	N/A
N/A	Painted X Walk1?	No	N/A	Painted X Walk2?	No
	X Walk 1 Direction	To SE		X Walk 2 Direction	To SW
	X Walk 1 Width (in)	N/A		X Walk 2 Width (in)	N/A
	X Walk 1 Slope (%)	0.9		X Walk 2 Slope (%)	5.0
	X Walk 1 X Slope (%)	5.1		X Walk 2 X Slope (%)	0.9

N/A	Ramp inside XWalk1?	N/A	N/A	Ramp inside XWalk2?	N/A
	Road Slope (%)	5.2		Clear Space?	N/A
	Road X Slope (%)	4.4	N/A	Clear Space to XWalk (in)	N/A
N/A	Any Obstructions?	N/A	N/A	Storm Grate/Utility Hazard?	N/A
	Obstruction Type			Storm Grate/Utility Type	
		N/A			N/A
			Yes	Surface Condition? (G/P)	Good
			No	Curb Slope (%)	17.6

**Remove & Replace Curb Ramp With Two New Directional Ramps or Equivalent.**
