Access Compliance Report

Public Rights-of-Way

(Curb Ramps)

Intersection ID: 10016842	Main Street: N_TRYON_ST	Cross Street: N/A	Location: N
ADA ID: 955DEF1EFFED	Ramp Type: PerpDiag	Initial Pass/Fail: Fail	Overall Compliance: No
		Severity Score: 60

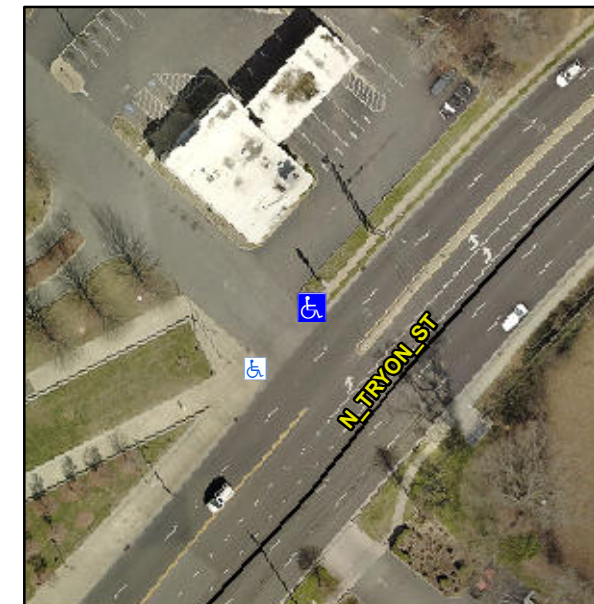
Not Found, R304.5.1, R304.2.2, R304.5.3

Compliance	Description	Data	Compliance	Description	Data
N/A	Ramp Length (in)	52.0	No	Ramp Slope (%)	11.1
No	Ramp Width (in)	24.0	No	Ramp XSlope (%)	6.3
N/A	Flare Type LT	N/A	N/A	Flare Type RT	N/A
N/A	Flare Slope LT (%)	N/A	N/A	Flare Slope RT (%)	N/A
N/A	Flare Traversable LT?	N/A	N/A	Flare Traversable RT?	N/A
N/A	Landing Length (in)	N/A	N/A	DWS Provided?	N/A
N/A	Landing Width (in)	N/A	N/A	DWS Contrast?	N/A
N/A	Landing Slope (%)	N/A	N/A	DWS Length (in)	N/A
N/A	Landing X Slope (%)	N/A	N/A	DWS Full Width?	N/A
N/A	Landing Curb? (Y/N)	N/A	N/A	DWS Offset (in)	N/A
N/A	Shared Landing?	N/A			
N/A	Gutter Ponding?	N/A	N/A	Gutter Slope (%)	N/A
N/A	Gutter Lip Ht (in)	N/A	N/A	Gutter X Slope (%)	N/A
N/A	Painted X Walk1?	No	N/A	Painted X Walk2?	No
	X Walk 1 Direction	To SW		X Walk 2 Direction	To SE
N/A	X Walk 1 Width (in)	N/A	N/A	X Walk 2 Width (in)	N/A
	X Walk 1 Slope (%)	2.3		X Walk 2 Slope (%)	0.7
	X Walk 1 X Slope (%)	5.2		X Walk 2 X Slope (%)	2.7

N/A	Ramp inside XWalk1?	N/A	N/A	Ramp inside XWalk2?	N/A
	Road Slope (%)	5.6	N/A	Clear Space?	N/A
	Road X Slope (%)	4.1	N/A	Clear Space to XWalk (in)	N/A
N/A	Any Obstructions?	N/A	N/A	Storm Grate/Utility Hazard?	N/A
	Obstruction Type			Storm Grate/Utility Type	
		N/A			N/A
			Yes	Surface Condition? (G/P)	Good

Remove & Replace Curb Ramp With Two New Directional Ramps or Equivalent.

Total Cost: \$ 3200.00
