Access Compliance Report

Public Rights-of-Way

(Curb Ramps)

Intersection ID: 12108	Main Street: CRESTMONT_DR	Cross Street: SHAMROCK_DR	Location: SW
ADA ID: 9563E9488658	Ramp Type: PerpDiag	Initial Pass/Fail: Fail	Overall Compliance: No
			Severity Score: 13.75

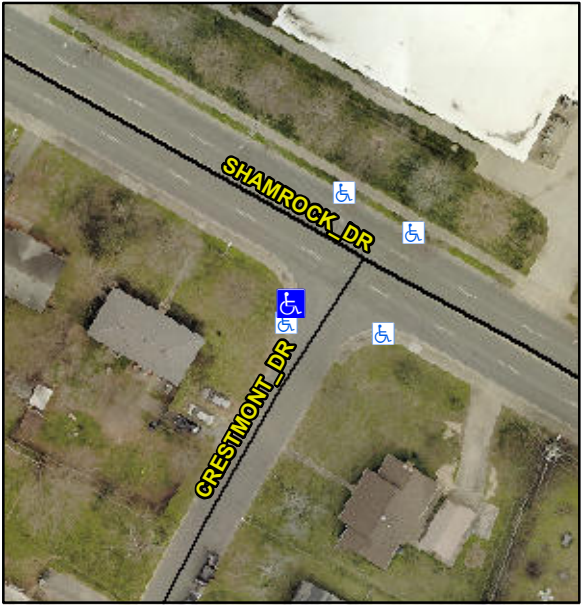
Possible Solutions:		Compliance	Description	Data
	Remove & Replace Curb Ramp With Two New Directional Ramps or Equivalent.		No	Ramp Length (in)	56.0
			Yes	Ramp Width (in)	48.0
			N/A	Flare Type LT	N/A
			N/A	Flare Slope LT (%)	N/A
			N/A	Flare Traversable LT?	N/A
			N/A	Landing Length (in)	N/A
			N/A	Landing Width (in)	N/A
			N/A	Landing Slope (%)	N/A
			N/A	Landing X Slope (%)	N/A
<p>Surveyor Notes:</p> <p>N/A</p> <p>PROW/ADA:</p> <p>Not Found, R304.2.2, R304.5.3</p>			N/A	Flare Type RT	N/A
			N/A	Flare Slope RT (%)	N/A
			N/A	Flare Traversable RT?	N/A
			N/A	DWS Provided?	N/A
			N/A	DWS Contrast?	N/A
			N/A	DWS Length (in)	N/A
			N/A	DWS Full Width?	N/A
			N/A	DWS Offset (in)	N/A
			N/A	Gutter Ponding?	N/A
			N/A	Gutter Lip Ht (in)	N/A
			No	Painted X Walk1?	No
				X Walk 1 Direction	To SE
			N/A	X Walk 1 Width (in)	N/A

0.2	X Walk 1 Slope (%)	6.2
			3.6	X Walk 1 X Slope (%)	1.1
			N/A	Ramp inside XWalk1?	N/A
			3.4	Road Slope (%)	N/A
			9.0	Road X Slope (%)	N/A
			N/A	Any Obstructions?	N/A
				Obstruction Type	
			N/A	Clear Space?	N/A
			N/A	Clear Space to XWalk (in)	N/A
			N/A	Storm Grate/Utility Hazard?	N/A
				Storm Grate/Utility Type	
			N/A		N/A
			Yes	Surface Condition? (G/P)	Good
Total Cost:		\$ 3200.00
