# Access Compliance Report

## Public Rights-of-Way

### (Curb Ramps)

Intersection ID: 28584	Main Street: FALCONCREST_DR	Cross Street: HIGHLAND_CREEK_PY	Location: E
ADA ID: 956612CA331F	Ramp Type: PerpDiag	Initial Pass/Fail: Fail	Overall Compliance: No
		Severity Score: 12.5

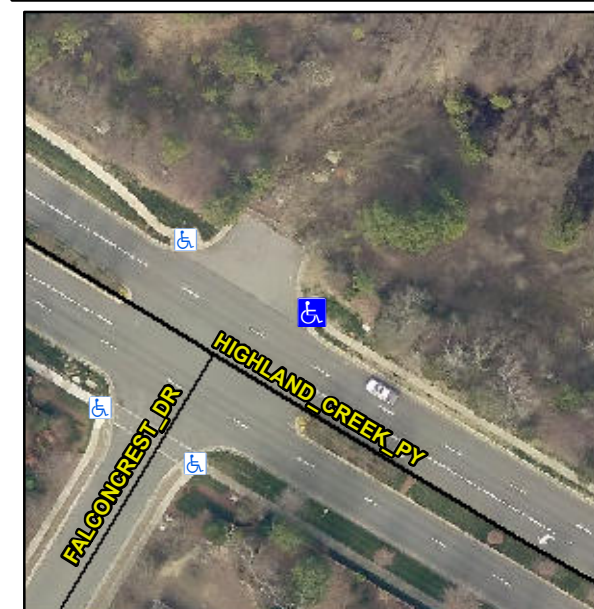
**Not Found, R304.2.2**

Compliance	Description	Data	Compliance	Description	Data
N/A	Ramp Length (in)	95.0	No	Ramp Slope (%)	8.7
Yes	Ramp Width (in)	51.0	Yes	Ramp XSlope (%)	1.9
N/A	Flare Type LT	N/A	N/A	Flare Type RT	N/A
N/A	Flare Slope LT (%)	N/A	N/A	Flare Slope RT (%)	N/A
N/A	Flare Traversable LT?	N/A	N/A	Flare Traversable RT?	N/A
N/A	Landing Length (in)	N/A	N/A	DWS Provided?	N/A
N/A	Landing Width (in)	N/A	N/A	DWS Contrast?	N/A
N/A	Landing Slope (%)	N/A	N/A	DWS Length (in)	N/A
N/A	Landing X Slope (%)	N/A	N/A	DWS Full Width?	N/A
N/A	Landing Curb? (Y/N)	N/A	N/A	DWS Offset (in)	N/A
N/A	Shared Landing?	N/A			
N/A	Gutter Ponding?	N/A	N/A	Gutter Slope (%)	N/A
N/A	Gutter Lip Ht (in)	3.0	N/A	Gutter X Slope (%)	N/A
N/A	Painted X Walk1?	No	N/A	Painted X Walk2?	No
	X Walk 1 Direction	To NW		X Walk 2 Direction	To SW
N/A	X Walk 1 Width (in)	N/A	N/A	X Walk 2 Width (in)	N/A
	X Walk 1 Slope (%)	0.9		X Walk 2 Slope (%)	0.3
	X Walk 1 X Slope (%)	1.2		X Walk 2 X Slope (%)	0.4

N/A	Ramp inside XWalk1?	N/A	N/A	Ramp inside XWalk2?	N/A
	Road Slope (%)	1.3	N/A	Clear Space?	N/A
	Road X Slope (%)	0.2	N/A	Clear Space to XWalk (in)	N/A
N/A	Any Obstructions?	N/A	N/A	Storm Grate/Utility Hazard?	N/A
	Obstruction Type			Storm Grate/Utility Type	
		N/A			N/A
			Yes	Surface Condition? (G/P)	Good

**Remove & Replace Curb Ramp With Two New Directional Ramps or Equivalent.**
