Access Compliance Report

Public Rights-of-Way

(Curb Ramps)

Intersection ID: 13782	Main Street: CENTRAL_AV	Cross Street: MEDFORD_DR	Location: SW
ADA ID: 95663D5F6C80	Ramp Type: Perp	Initial Pass/Fail: Fail	Overall Compliance: No
		Severity Score: 10

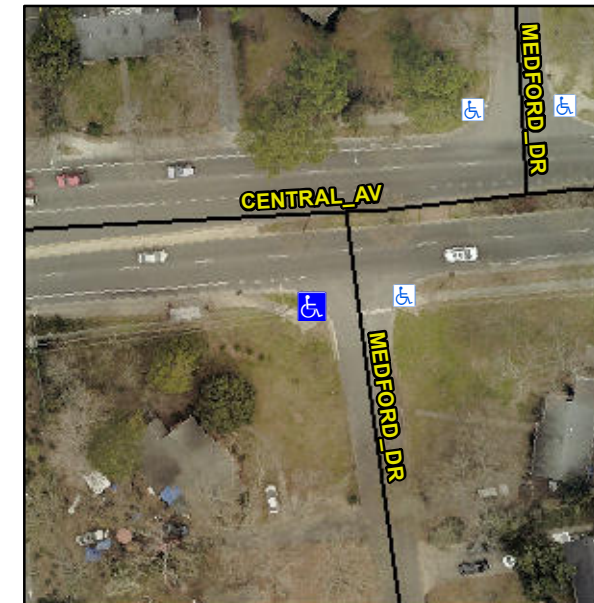
Not Found, R304.5.1, R304.5.3

Compliance	Description	Data	Compliance	Description	Data
N/A	Ramp Length (in)	89.0	Yes	Ramp Slope (%)	5.0
No	Ramp Width (in)	37.5	No	Ramp XSlope (%)	2.6
N/A	Flare Type LT	N/A	N/A	Flare Type RT	N/A
N/A	Flare Slope LT (%)	N/A	N/A	Flare Slope RT (%)	N/A
N/A	Flare Traversable LT?	N/A	N/A	Flare Traversable RT?	N/A
N/A	Landing Length (in)	N/A	N/A	DWS Provided?	N/A
N/A	Landing Width (in)	N/A	N/A	DWS Contrast?	N/A
N/A	Landing Slope (%)	N/A	N/A	DWS Length (in)	N/A
N/A	Landing X Slope (%)	N/A	N/A	DWS Full Width?	N/A
N/A	Landing Curb? (Y/N)	N/A	N/A	DWS Offset (in)	N/A
N/A	Shared Landing?	N/A			
N/A	Gutter Ponding?	N/A	N/A	Gutter Slope (%)	N/A
N/A	Gutter Lip Ht (in)	N/A	N/A	Gutter X Slope (%)	N/A
N/A	Painted X Walk1?	No	N/A	Painted X Walk2?	N/A
	X Walk 1 Direction	To E		X Walk 2 Direction	N/A
N/A	X Walk 1 Width (in)	N/A	N/A	X Walk 2 Width (in)	N/A
	X Walk 1 Slope (%)	2.2		X Walk 2 Slope (%)	N/A
	X Walk 1 X Slope (%)	2.3		X Walk 2 X Slope (%)	N/A

N/A	Ramp inside XWalk1?	N/A	N/A	Ramp inside XWalk2?	N/A
	Road Slope (%)	N/A	N/A	Clear Space?	N/A
	Road X Slope (%)	N/A	N/A	Clear Space to XWalk (in)	N/A
N/A	Any Obstructions?	N/A	N/A	Storm Grate/Utility Hazard?	N/A
	Obstruction Type			Storm Grate/Utility Type	
		N/A			N/A
			Yes	Surface Condition? (G/P)	Good

Remove & Replace Entire Ramp.
