Access Compliance Report

Public Rights-of-Way

(Curb Ramps)

Intersection ID: 46324	Main Street: ARBOR_VISTA_DR	Cross Street: SENATOR_ROYALL_DR	Location: SW
ADA ID: 957234257DE4	Ramp Type: PerpDiag	Initial Pass/Fail: Fail	Overall Compliance: No
Severity Score: 8.75			
Codes/Mitigation Info/Possible Solution		Field Measurements/Component Compliance

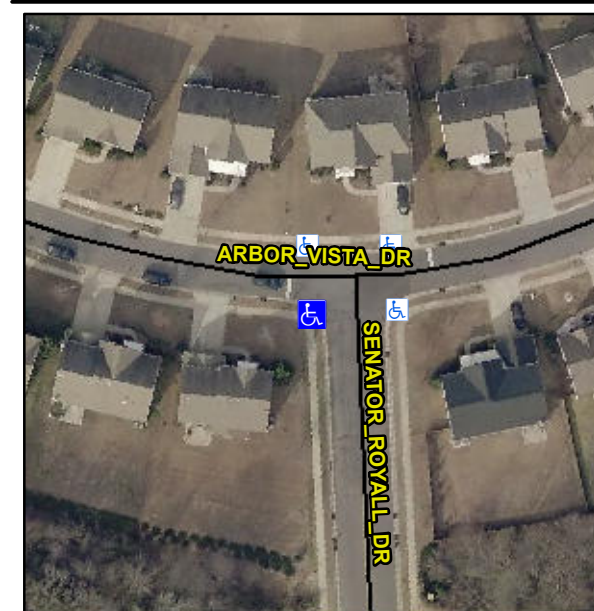
Not Found, R304.5.1

Compliance	Description	Data	Compliance	Description	Data
N/A	Ramp Length (in)	49.0	Yes	Ramp Slope (%)	5.7
No	Ramp Width (in)	43.5	Yes	Ramp XSlope (%)	0.6
N/A	Flare Type LT	N/A	N/A	Flare Type RT	N/A
N/A	Flare Slope LT (%)	N/A	N/A	Flare Slope RT (%)	N/A
N/A	Flare Traversable LT?	N/A	N/A	Flare Traversable RT?	N/A
N/A	Landing Length (in)	N/A	N/A	DWS Provided?	N/A
N/A	Landing Width (in)	N/A	N/A	DWS Contrast?	N/A
N/A	Landing Slope (%)	N/A	N/A	DWS Length (in)	N/A
N/A	Landing X Slope (%)	N/A	N/A	DWS Full Width?	N/A
N/A	Landing Curb? (Y/N)	N/A	N/A	DWS Offset (in)	N/A
N/A	Shared Landing?	N/A			
N/A	Gutter Ponding?	N/A	N/A	Gutter Slope (%)	N/A
N/A	Gutter Lip Ht (in)	N/A	N/A	Gutter X Slope (%)	N/A
N/A	Painted X Walk1?	No	N/A	Painted X Walk2?	No
	X Walk 1 Direction	To N		X Walk 2 Direction	To E
N/A	X Walk 1 Width (in)	N/A	N/A	X Walk 2 Width (in)	N/A
	X Walk 1 Slope (%)	2.6		X Walk 2 Slope (%)	3.1
	X Walk 1 X Slope (%)	1.9		X Walk 2 X Slope (%)	1.1

N/A	Ramp inside XWalk1?	N/A	N/A	Ramp inside XWalk2?	N/A
	Road Slope (%)	2.0	N/A	Clear Space?	N/A
	Road X Slope (%)	2.7	N/A	Clear Space to XWalk (in)	N/A
N/A	Any Obstructions?	N/A	N/A	Storm Grate/Utility Hazard?	N/A
	Obstruction Type			Storm Grate/Utility Type	
		N/A			N/A
			Yes	Surface Condition? (G/P)	Good

Possible Solutions:

Remove & Replace Curb Ramp With Two New Directional Ramps or Equivalent.
