Access Compliance Report

Public Rights-of-Way

(Curb Ramps)

Intersection ID: 2412	Main Street: HIDDEN_MEADOW_LN	Cross Street: LAUREL_RUN_DR	Location: E
ADA ID: 9576DA9ADDA6	Ramp Type: PerpDiag	Initial Pass/Fail: Fail	Overall Compliance: No
		Severity Score: 25

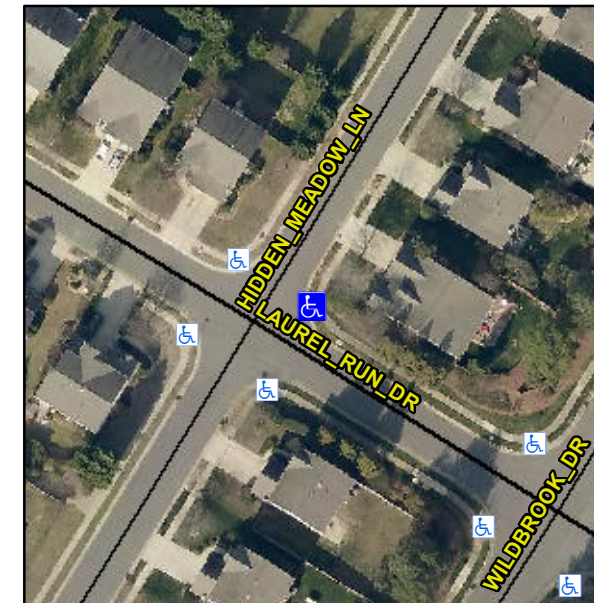
Not Found, R304.2.2, R304.5.3

Compliance	Description	Data	Compliance	Description	Data
N/A	Ramp Length (in)	48.0	No	Ramp Slope (%)	9.1
Yes	Ramp Width (in)	48.0	No	Ramp XSlope (%)	6.4
N/A	Flare Type LT	N/A	N/A	Flare Type RT	N/A
N/A	Flare Slope LT (%)	N/A	N/A	Flare Slope RT (%)	N/A
N/A	Flare Traversable LT?	N/A	N/A	Flare Traversable RT?	N/A
N/A	Landing Length (in)	N/A	N/A	DWS Provided?	N/A
N/A	Landing Width (in)	N/A	N/A	DWS Contrast?	N/A
N/A	Landing Slope (%)	N/A	N/A	DWS Length (in)	N/A
N/A	Landing X Slope (%)	N/A	N/A	DWS Full Width?	N/A
N/A	Landing Curb? (Y/N)	N/A	N/A	DWS Offset (in)	N/A
N/A	Shared Landing?	N/A			
N/A	Gutter Ponding?	N/A	N/A	Gutter Slope (%)	N/A
N/A	Gutter Lip Ht (in)	N/A	N/A	Gutter X Slope (%)	N/A
N/A	Painted X Walk1?	No	N/A	Painted X Walk2?	No
	X Walk 1 Direction	To NW		X Walk 2 Direction	To SW
N/A	X Walk 1 Width (in)	N/A	N/A	X Walk 2 Width (in)	N/A
	X Walk 1 Slope (%)	2.6		X Walk 2 Slope (%)	5.1
	X Walk 1 X Slope (%)	4.4		X Walk 2 X Slope (%)	1.1

N/A	Ramp inside XWalk1?	N/A	N/A	Ramp inside XWalk2?	N/A
	Road Slope (%)	3.7	N/A	Clear Space?	N/A
	Road X Slope (%)	0.1	N/A	Clear Space to XWalk (in)	N/A
N/A	Any Obstructions?	N/A	N/A	Storm Grate/Utility Hazard?	N/A
	Obstruction Type			Storm Grate/Utility Type	
		N/A			N/A
			Yes	Surface Condition? (G/P)	Good

Remove & Replace Curb Ramp With Two New Directional Ramps or Equivalent.

Total Cost: \$ 3200.00
