# Access Compliance Report

## Public Rights-of-Way

### (Curb Ramps)

Intersection ID: 47830	Main Street: STONEDALE_CT	Cross Street: OAKDALE_RD	Location: SW
ADA ID: 958799C3C08E	Ramp Type: Perp	Initial Pass/Fail: Fail	Overall Compliance: No
Codes/Mitigation Info/Possible Solution		Field Measurements/Component Compliance	
Severity Score: 46.25

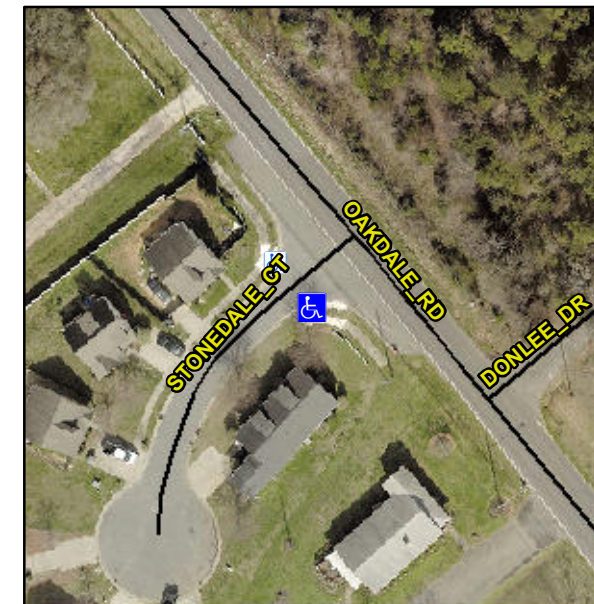
**Not Found, R304.5.1, R304.2.2, R304.5.3**

Compliance	Description	Data	Compliance	Description	Data
N/A	Ramp Length (in)	46.0	No	Ramp Slope (%)	11.3
No	Ramp Width (in)	45.0	No	Ramp XSlope (%)	9.5
N/A	Flare Type LT	N/A	N/A	Flare Type RT	N/A
N/A	Flare Slope LT (%)	N/A	N/A	Flare Slope RT (%)	N/A
N/A	Flare Traversable LT?	N/A	N/A	Flare Traversable RT?	N/A
N/A	Landing Length (in)	N/A	N/A	DWS Provided?	N/A
N/A	Landing Width (in)	N/A	N/A	DWS Contrast?	N/A
N/A	Landing Slope (%)	N/A	N/A	DWS Length (in)	N/A
N/A	Landing X Slope (%)	N/A	N/A	DWS Full Width?	N/A
N/A	Landing Curb? (Y/N)	N/A	N/A	DWS Offset (in)	N/A
N/A	Shared Landing?	N/A			
N/A	Gutter Ponding?	N/A	N/A	Gutter Slope (%)	N/A
N/A	Gutter Lip Ht (in)	N/A	N/A	Gutter X Slope (%)	N/A
N/A	Painted X Walk1?	No	N/A	Painted X Walk2?	N/A
	X Walk 1 Direction	To NW		X Walk 2 Direction	N/A
N/A	X Walk 1 Width (in)	N/A	N/A	X Walk 2 Width (in)	N/A
	X Walk 1 Slope (%)	1.2		X Walk 2 Slope (%)	N/A
	X Walk 1 X Slope (%)	5.5		X Walk 2 X Slope (%)	N/A

**Remove & Replace Entire Ramp.**

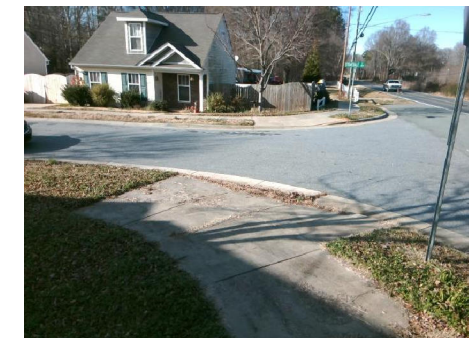
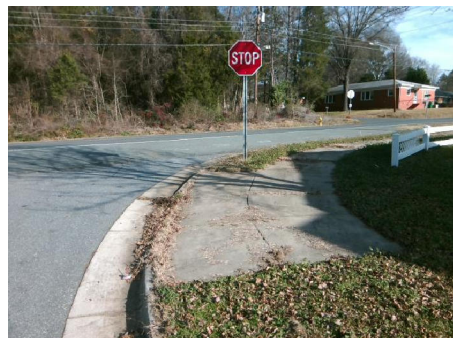
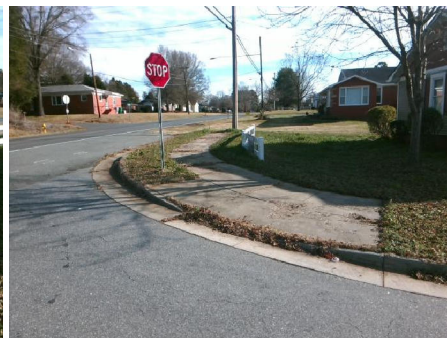
N/A	Ramp inside XWalk1?	N/A	N/A	Ramp inside XWalk2?	N/A
	Road Slope (%)	N/A	N/A	Clear Space?	N/A
	Road X Slope (%)	N/A	N/A	Clear Space to XWalk (in)	N/A
N/A	Any Obstructions?	N/A	N/A	Storm Grate/Utility Hazard?	N/A
	Obstruction Type			Storm Grate/Utility Type	
		N/A			N/A
			Yes	Surface Condition? (G/P)	Good
