Access Compliance Report

Public Rights-of-Way

(Curb Ramps)

Intersection ID: 10035557	Main Street: REA_RD	Cross Street: N/A	Location: SE
ADA ID: 95881901E26B	Ramp Type: PerpDiag	Initial Pass/Fail: Fail	Overall Compliance: No
Severity Score: 22.5			
Codes/Mitigation Info/Possible Solution		Field Measurements/Component Compliance

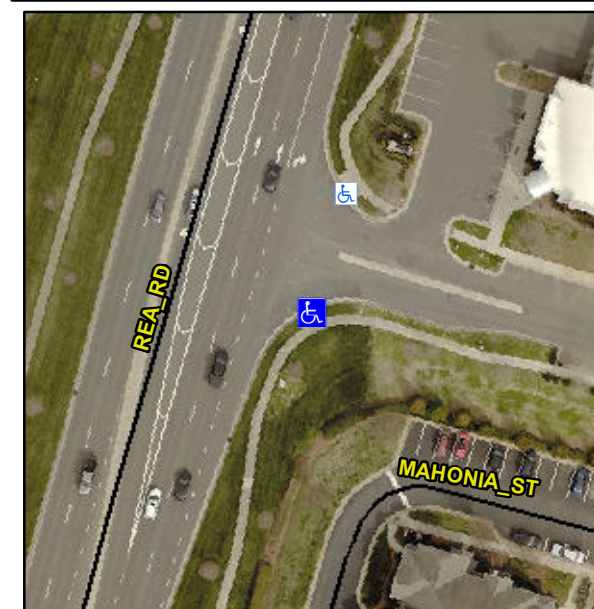
Not Found, R304.5.1, R304.2.2, R304.5.3

Compliance	Description	Data	Compliance	Description	Data
N/A	Ramp Length (in)	75.0	No	Ramp Slope (%)	11.7
No	Ramp Width (in)	44.0	No	Ramp XSlope (%)	3.3
N/A	Flare Type LT	N/A	N/A	Flare Type RT	N/A
N/A	Flare Slope LT (%)	N/A	N/A	Flare Slope RT (%)	N/A
N/A	Flare Traversable LT?	N/A	N/A	Flare Traversable RT?	N/A
N/A	Landing Length (in)	N/A	N/A	DWS Provided?	N/A
N/A	Landing Width (in)	N/A	N/A	DWS Contrast?	N/A
N/A	Landing Slope (%)	N/A	N/A	DWS Length (in)	N/A
N/A	Landing X Slope (%)	N/A	N/A	DWS Full Width?	N/A
N/A	Landing Curb? (Y/N)	N/A	N/A	DWS Offset (in)	N/A
N/A	Shared Landing?	N/A			
N/A	Gutter Ponding?	N/A	N/A	Gutter Slope (%)	N/A
N/A	Gutter Lip Ht (in)	N/A	N/A	Gutter X Slope (%)	N/A
N/A	Painted X Walk1?	No	N/A	Painted X Walk2?	No
	X Walk 1 Direction	To NE		X Walk 2 Direction	To NW
N/A	X Walk 1 Width (in)	N/A	N/A	X Walk 2 Width (in)	N/A
	X Walk 1 Slope (%)	0.9		X Walk 2 Slope (%)	3.4
	X Walk 1 X Slope (%)	2.3		X Walk 2 X Slope (%)	0.7

N/A	Ramp inside XWalk1?	N/A	N/A	Ramp inside XWalk2?	N/A
	Road Slope (%)	1.7	N/A	Clear Space?	N/A
	Road X Slope (%)	2.5	N/A	Clear Space to XWalk (in)	N/A
N/A	Any Obstructions?	N/A	N/A	Storm Grate/Utility Hazard?	N/A
	Obstruction Type			Storm Grate/Utility Type	
		N/A			N/A
			Yes	Surface Condition? (G/P)	Good

Remove & Replace Curb Ramp With Two New Directional Ramps or Equivalent.
