Access Compliance Report Public Rights-of-Way (Curb Ramps)

Intersection ID: N/A Main Street: PROVIDENCE_RD Cross Street: N/A Location: NW **Overall Compliance: No** ADA ID: 9588D1BB71F6 Ramp Type: Perp Initial Pass/Fail: Fail Severity Score: 13.75

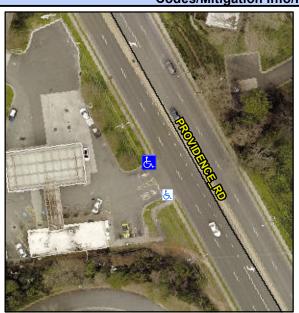
Field Measurements/Component Compliance								
Comp	liance Description	Data	Comp	liance	Description	Data		
N/A	Ramp Length (in)	74.0	No	Ramp	Slope (%)	11.7		
Yes	Ramp Width (in)	53.0	Yes	Ramp XSlope (%)		2.3		
N/A	Flare Type LT	N/A	N/A	Flare Type RT		N/A		
N/A	Flare Slope LT (%)	N/A	N/A	Flare S	Slope RT (%)	N/A		
N/A	Flare Traversable LT?	N/A	N/A	Flare T	raversable RT?	N/A		
N/A	Landing Length (in)	N/A	N/A	DWS F	Provided?	N/A		
N/A	Landing Width (in)	N/A	N/A	DWS (Contrast?	N/A		
N/A	Landing Slope (%)	N/A	N/A	DWS L	ength (in)	N/A		
N/A	Landing X Slope (%)	N/A	N/A	DWS F	Full Width?	N/A		
N/A	Landing Curb? (Y/N)	N/A	N/A	DWS (Offset (in)	N/A		
N/A	Shared Landing?	N/A						
N/A	Gutter Ponding?	N/A	N/A	Gutter	Slope (%)	N/A		
N/A	Gutter Lip Ht (in)	N/A	N/A	Gutter	X Slope (%)	N/A		
N/A	Painted X Walk1?	No	N/A	Painte	d X Walk2?	N/A		
	X Walk 1 Direction	To S		X Walk	2 Direction	N/A		
N/A	X Walk 1 Width (in)	N/A	N/A	X Walk	2 Width (in)	N/A

X Walk 1 Slope (%)	2.9		X Walk	(2 Slope (%)	N/A		
	X Walk 1 X Slope (%)	6.3		X Walk	(2 X Slope (%)	N/A		
N/A	Ramp inside XWalk1?	N/A	N/A	Ramp	inside XWalk2?	N/A		
	Road Slope (%)	N/A	N/A	Clear S	Space?	N/A		
	Road X Slope (%)	N/A	N/A	Clear S	Space to XWalk (in)	N/A		
N/A	Any Obstructions?	N/A	N/A	Storm	Grate/Utility Hazard?	N/A		
	Obstruction Type			Storm	Grate/Utility Type			
		N/A				N/A		
			Yes	Surfac	e Condition? (G/P)	Good

Possible Solutions:	<u>c</u>		
Remove & Replace Entire Ramp.			
	Y		
	N		
	N		
	N		
	N		
Surveyor Notes:	N		
N/A	N		
	N		
	N		
	N		
PROW/ADA:	N		
Not Found, R304.2.2	N		
	N		
	N

Total Cost: 1850.00
