# Access Compliance Report

## Public Rights-of-Way

### (Curb Ramps)

Intersection ID: 3857	Main Street: MOUNTAIN_PARK_DR	Cross Street: MOUNTAIN_TRAIL_DR	Location: SW
ADA ID: 959041E337DB	Ramp Type: PerpDiag	Initial Pass/Fail: Fail	Overall Compliance: No
Severity Score: 13.75			
Codes/Mitigation Info/Possible Solution		Field Measurements/Component Compliance

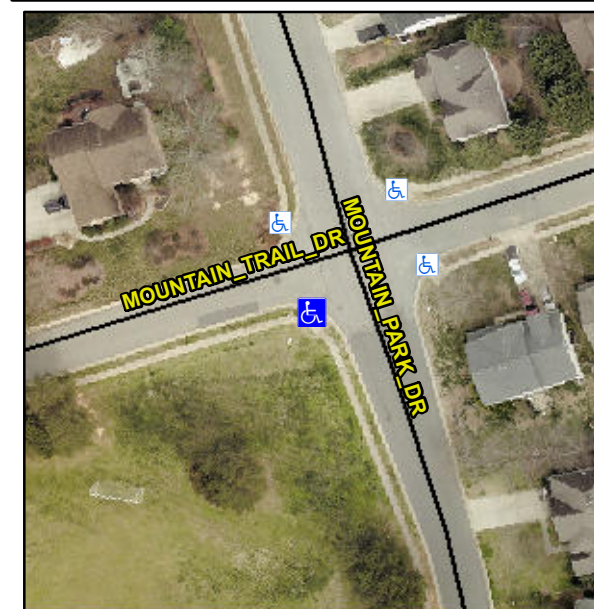
**Not Found, R304.2.2, R304.5.3**

Compliance	Description	Data	Compliance	Description	Data
N/A	Ramp Length (in)	48.0	No	Ramp Slope (%)	8.4
Yes	Ramp Width (in)	48.0	No	Ramp XSlope (%)	3.8
N/A	Flare Type LT	N/A	N/A	Flare Type RT	N/A
N/A	Flare Slope LT (%)	N/A	N/A	Flare Slope RT (%)	N/A
N/A	Flare Traversable LT?	N/A	N/A	Flare Traversable RT?	N/A
N/A	Landing Length (in)	N/A	N/A	DWS Provided?	N/A
N/A	Landing Width (in)	N/A	N/A	DWS Contrast?	N/A
N/A	Landing Slope (%)	N/A	N/A	DWS Length (in)	N/A
N/A	Landing X Slope (%)	N/A	N/A	DWS Full Width?	N/A
N/A	Landing Curb? (Y/N)	N/A	N/A	DWS Offset (in)	N/A
N/A	Shared Landing?	N/A			
N/A	Gutter Ponding?	N/A	N/A	Gutter Slope (%)	N/A
N/A	Gutter Lip Ht (in)	N/A	N/A	Gutter X Slope (%)	N/A
N/A	Painted X Walk1?	No	N/A	Painted X Walk2?	No
	X Walk 1 Direction	To E		X Walk 2 Direction	To N
N/A	X Walk 1 Width (in)	N/A	N/A	X Walk 2 Width (in)	N/A
	X Walk 1 Slope (%)	4.3		X Walk 2 Slope (%)	1.8
	X Walk 1 X Slope (%)	0.5		X Walk 2 X Slope (%)	5.3

N/A	Ramp inside XWalk1?	N/A	N/A	Ramp inside XWalk2?	N/A
	Road Slope (%)	3.2	N/A	Clear Space?	N/A
	Road X Slope (%)	4.4	N/A	Clear Space to XWalk (in)	N/A
N/A	Any Obstructions?	N/A	N/A	Storm Grate/Utility Hazard?	N/A
	Obstruction Type			Storm Grate/Utility Type	
		N/A			N/A
			Yes	Surface Condition? (G/P)	Good

**Remove & Replace Curb Ramp With Two New Directional Ramps or Equivalent.**

Total Cost: \$ 3200.00
