Access Compliance Report

Public Rights-of-Way

(Curb Ramps)

Intersection ID: 25785	Main Street: CARMEL_EXECUTIVE_PARK	Cross Street: PINEVILLE-MATTHEWS_RD	Location: NW
ADA ID: 95964E2A1A18	Ramp Type: Perp	Initial Pass/Fail: Fail	Overall Compliance: No
Severity Score: 30			
Codes/Mitigation Info/Possible Solution		Field Measurements/Component Compliance

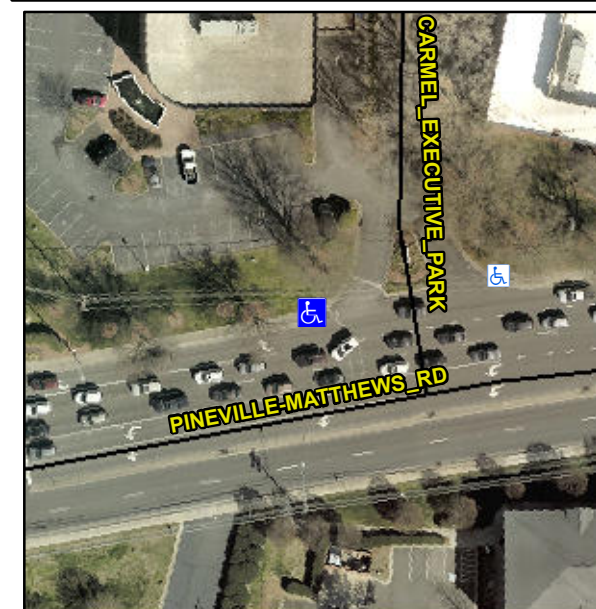
Not Found, R304.5.1, R304.2.2

Compliance	Description	Data	Compliance	Description	Data
N/A	Ramp Length (in)	60.0	No	Ramp Slope (%)	8.6
No	Ramp Width (in)	34.0	Yes	Ramp XSlope (%)	0.7
N/A	Flare Type LT	N/A	N/A	Flare Type RT	N/A
N/A	Flare Slope LT (%)	N/A	N/A	Flare Slope RT (%)	N/A
N/A	Flare Traversable LT?	N/A	N/A	Flare Traversable RT?	N/A
N/A	Landing Length (in)	N/A	N/A	DWS Provided?	N/A
N/A	Landing Width (in)	N/A	N/A	DWS Contrast?	N/A
N/A	Landing Slope (%)	N/A	N/A	DWS Length (in)	N/A
N/A	Landing X Slope (%)	N/A	N/A	DWS Full Width?	N/A
N/A	Landing Curb? (Y/N)	N/A	N/A	DWS Offset (in)	N/A
N/A	Shared Landing?	N/A			
N/A	Gutter Ponding?	N/A	N/A	Gutter Slope (%)	N/A
N/A	Gutter Lip Ht (in)	N/A	N/A	Gutter X Slope (%)	N/A
N/A	Painted X Walk1?	No	N/A	Painted X Walk2?	N/A
	X Walk 1 Direction	To E		X Walk 2 Direction	N/A
N/A	X Walk 1 Width (in)	N/A	N/A	X Walk 2 Width (in)	N/A
	X Walk 1 Slope (%)	0.4		X Walk 2 Slope (%)	N/A
	X Walk 1 X Slope (%)	1.8		X Walk 2 X Slope (%)	N/A

N/A	Ramp inside XWalk1?	N/A	N/A	Ramp inside XWalk2?	N/A
	Road Slope (%)	N/A	N/A	Clear Space?	N/A
	Road X Slope (%)	N/A	N/A	Clear Space to XWalk (in)	N/A
N/A	Any Obstructions?	N/A	N/A	Storm Grate/Utility Hazard?	N/A
	Obstruction Type			Storm Grate/Utility Type	
		N/A			N/A
			Yes	Surface Condition? (G/P)	Good

Possible Solutions:

Remove & Replace Entire Ramp.
