# Access Compliance Report

## Public Rights-of-Way

### (Curb Ramps)

Intersection ID: 14536	Main Street: CARONIA_ST	Cross Street: RIDGE_AV	Location: SE
ADA ID: 95965A6367BE	Ramp Type: PerpDiag	Initial Pass/Fail: Fail	Overall Compliance: No
Severity Score: 46.25			
Codes/Mitigation Info/Possible Solution		Field Measurements/Component Compliance

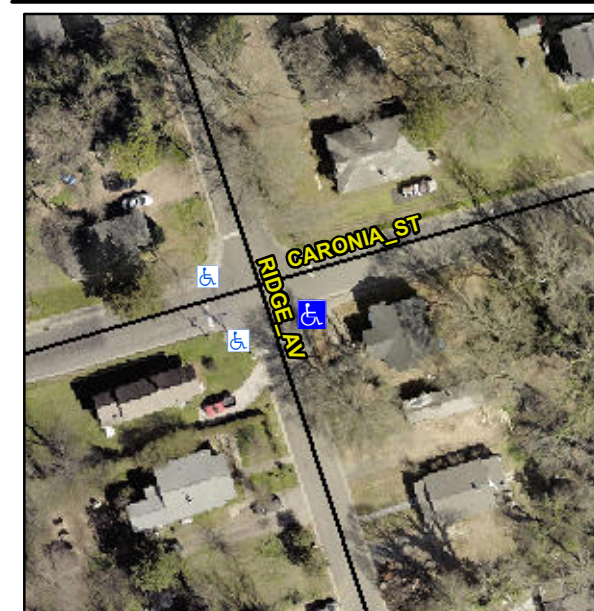
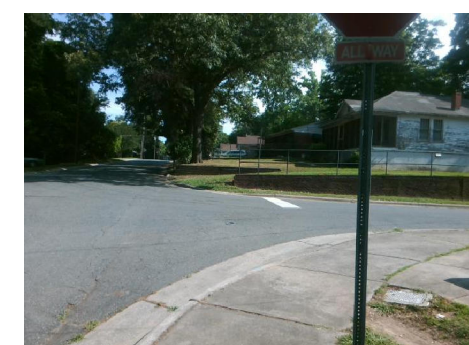
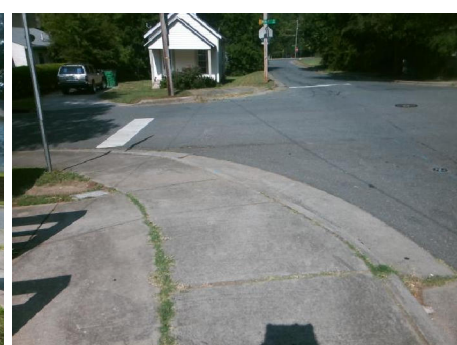
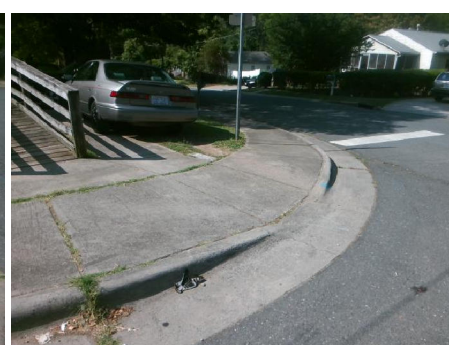
**Not Found, R304.5.1, R304.2.2, R304.5.3**

Compliance	Description	Data	Compliance	Description	Data
N/A	Ramp Length (in)	61.0	No	Ramp Slope (%)	8.9
No	Ramp Width (in)	42.0	No	Ramp XSlope (%)	10.4
N/A	Flare Type LT	N/A	N/A	Flare Type RT	N/A
N/A	Flare Slope LT (%)	N/A	N/A	Flare Slope RT (%)	N/A
N/A	Flare Traversable LT?	N/A	N/A	Flare Traversable RT?	N/A
N/A	Landing Length (in)	N/A	N/A	DWS Provided?	N/A
N/A	Landing Width (in)	N/A	N/A	DWS Contrast?	N/A
N/A	Landing Slope (%)	N/A	N/A	DWS Length (in)	N/A
N/A	Landing X Slope (%)	N/A	N/A	DWS Full Width?	N/A
N/A	Landing Curb? (Y/N)	N/A	N/A	DWS Offset (in)	N/A
N/A	Shared Landing?	N/A			
N/A	Gutter Ponding?	N/A	N/A	Gutter Slope (%)	N/A
N/A	Gutter Lip Ht (in)	N/A	N/A	Gutter X Slope (%)	N/A
N/A	Painted X Walk1?	No	N/A	Painted X Walk2?	No
	X Walk 1 Direction	To N		X Walk 2 Direction	To W
N/A	X Walk 1 Width (in)	N/A	N/A	X Walk 2 Width (in)	N/A
	X Walk 1 Slope (%)	4.7		X Walk 2 Slope (%)	3.8
	X Walk 1 X Slope (%)	4.8		X Walk 2 X Slope (%)	8.8

N/A	Ramp inside XWalk1?	N/A	N/A	Ramp inside XWalk2?	N/A
	Road Slope (%)	7.2	N/A	Clear Space?	N/A
	Road X Slope (%)	0.0	N/A	Clear Space to XWalk (in)	N/A
N/A	Any Obstructions?	N/A	N/A	Storm Grate/Utility Hazard?	N/A
	Obstruction Type			Storm Grate/Utility Type	
		N/A			N/A
			Yes	Surface Condition? (G/P)	Good

**Remove & Replace Curb Ramp With Two New Directional Ramps or Equivalent.**
