Access Compliance Report

Public Rights-of-Way

(Curb Ramps)

Intersection ID: 15211	Main Street: EAST_BV	Cross Street: SCOTT_AV	Location: N
ADA ID: 959C0A290064	Ramp Type: PerpDiag	Initial Pass/Fail: Fail	Overall Compliance: No
			Severity Score: 13.75

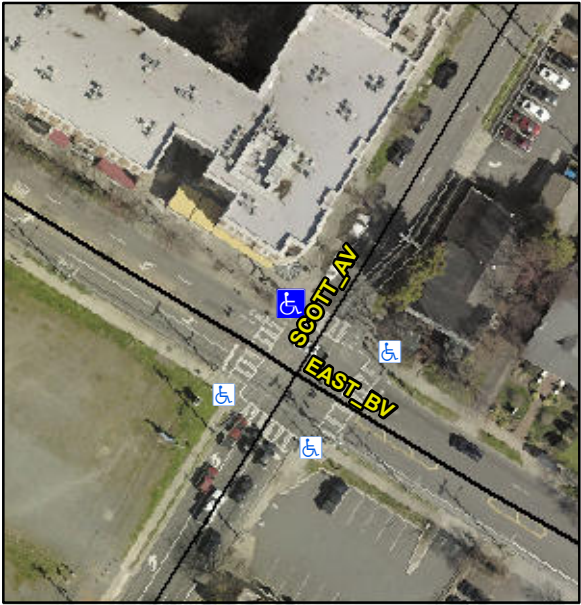
Possible Solutions:		Compliance	Description	Data
	Remove & Replace Curb Ramp With Two New Directional Ramps or Equivalent.		N/A	Ramp Length (in)	51.0
			Yes	Ramp Width (in)	72.0
			N/A	Flare Type LT	N/A
			N/A	Flare Slope LT (%)	N/A
			N/A	Flare Traversable LT?	N/A
			N/A	Landing Length (in)	N/A
			N/A	Landing Width (in)	N/A
			N/A	Landing Slope (%)	N/A
			N/A	Landing X Slope (%)	N/A
			N/A	Landing Curb? (Y/N)	N/A
			N/A	Shared Landing?	N/A
			N/A	Gutter Ponding?	N/A
			N/A	Gutter Lip Ht (in)	N/A
			N/A	Painted X Walk1?	Yes
				X Walk 1 Direction	To SW
			N/A	X Walk 1 Width (in)	108.0
				X Walk 1 Slope (%)	4.8
				X Walk 1 X Slope (%)	0.0
			N/A	Ramp inside XWalk1?	Yes
<p>Surveyor Notes:</p> <p>N/A</p> <p>PROW/ADA:</p> <p>Not Found, R304.2.2, R304.5.3</p>			N/A	Flare Type RT	N/A
			N/A	Flare Slope RT (%)	N/A
			N/A	Flare Traversable RT?	N/A

N/A	DWS Provided?	N/A
			N/A	DWS Contrast?	N/A
			N/A	DWS Length (in)	N/A
			N/A	DWS Full Width?	N/A
			N/A	DWS Offset (in)	N/A
			N/A	Gutter Slope (%)	N/A
			N/A	Gutter X Slope (%)	N/A
			N/A	Painted X Walk2?	Yes
				X Walk 2 Direction	To SE
			N/A	X Walk 2 Width (in)	114.0
				X Walk 2 Slope (%)	0.2
				X Walk 2 X Slope (%)	4.2
			N/A	Ramp inside XWalk2?	Yes
			N/A	Clear Space?	N/A
			N/A	Clear Space to XWalk (in)	N/A
			N/A	Storm Grate/Utility Hazard?	N/A
				Storm Grate/Utility Type	
			N/A		N/A
			Yes	Surface Condition? (G/P)	Good
Street 1 Name	EAST BV				
Stop Condition-Street 2	Signal				
Street 2 Name	SCOTT AV				
Stop Condition-Street 1	Signal				
Total Cost:	\$	3200.00
