Access Compliance Report Public Rights-of-Way (Curb Ramps)

Main Street: CLARKE CREEK PY **Cross Street: BROOKINGS DR** Location: Intersection ID: 2453 NE Ramp Type: Combination2 Initial Pass/Fail: Fail **Overall Compliance: No** ADA ID: 95A029A10D8B Severity Score: 26.25

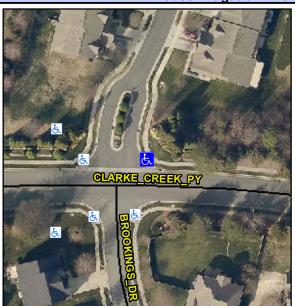
1 3 ()	-		1 1 \ /	
Yes	Ramp Width (in)	48.0	No	Ramp XSlope (%)	4.1
N/A	Flare Type LT	N/A	N/A	Flare Type RT	N/A
N/A	Flare Slope LT (%)	N/A	N/A	Flare Slope RT (%)	N/A
N/A	Flare Traversable LT?	N/A	N/A	Flare Traversable RT?	N/A
N/A	Landing Length (in)	N/A	N/A	DWS Provided?	N/A
N/A	Landing Width (in)	N/A	N/A	DWS Contrast?	N/A
N/A	Landing Slope (%)	N/A	N/A	DWS Length (in)	N/A
N/A	Landing X Slope (%)	N/A	N/A	DWS Full Width?	N/A
N/A	Landing Curb? (Y/N)	N/A	N/A	DWS Offset (in)	N/A
N/A	Shared Landing?	N/A			
N/A	Gutter Ponding?	N/A	N/A	Gutter Slope (%)	N/A
N/A	Gutter Lip Ht (in)	N/A	N/A	Gutter X Slope (%)	N/A
N/A	Painted X Walk1?	No	N/A	Painted X Walk2?	No
	X Walk 1 Direction	To W		X Walk 2 Direction	N/A
	X Walk 1 Width (in)	N/A		X Walk 2 Width (in)	N/A
	X Walk 1 Slope (%)	3.8		X Walk 2 Slope (%)	1.7
	X Walk 1 X Slope (%)	3.3		X Walk 2 X Slope (%)	4.4
N/A	Ramp inside XWalk1?	N/A	N/A	Ramp inside XWalk2?	N/A
	Road Slope (%)	3.5		Clear Space?	N/A

Street 1 Name StopSign Stop Condition-Street 1 **BROOKINGS DR** N/A Street 2 Name Stop Condition-Street 2 N/A Possible Solutions: Compliance Description Remove & Replace Entire Ramp. N/A Yes No Yes N/A Yes Surveyor Notes: N/A N/A N/A N/A N/A N/A PROW/ADA: N/A R304.2.2, R304.5.3, R304.3.2 N/A N/A N/A N/A N/A N/A
