# Access Compliance Report

## Public Rights-of-Way

### (Curb Ramps)

Intersection ID: 30184	Main Street: BEATTIES_FORD_RD	Cross Street: SLATER_SPRINGS_DR	Location: SE
ADA ID: 95AB68A635D6	Ramp Type: Combination1	Initial Pass/Fail: Fail	Overall Compliance: No
Severity Score: 33.75			
Codes/Mitigation Info/Possible Solution		Field Measurements/Component Compliance

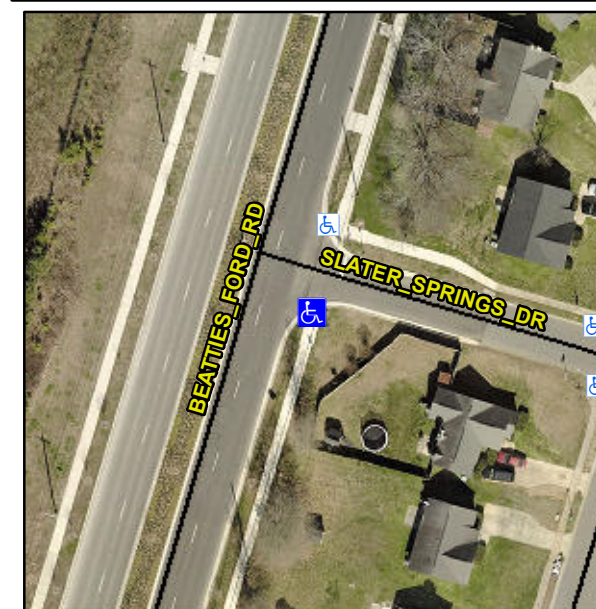
**LT RP < 5%**

**Not Found, R304.5.1, R304.5.3, R304.3.2**

Compliance	Description	Data	Compliance	Description	Data
N/A	Ramp Length LT (in)	56.0	N/A	Ramp Length RT (in)	49.5
Yes	Ramp Width LT (in)	49.0	Yes	Ramp Width RT (in)	53.5
Yes	Ramp Slope LT (%)	4.8	No	Ramp Slope RT (%)	8.5
No	Ramp XSlope LT (%)	2.2	Yes	Ramp XSlope RT (%)	1.4
N/A	Ramp Length (in)	52.0	Yes	Ramp Slope (%)	6.6
No	Ramp Width (in)	42.0	No	Ramp XSlope (%)	5.9
N/A	Flare Type LT	N/A	N/A	Flare Type RT	N/A
N/A	Flare Slope LT (%)	N/A	N/A	Flare Slope RT (%)	N/A
N/A	Flare Traversable LT?	N/A	N/A	Flare Traversable RT?	N/A
N/A	Landing Length (in)	N/A	N/A	DWS Provided?	N/A
N/A	Landing Width (in)	N/A	N/A	DWS Contrast?	N/A
N/A	Landing Slope (%)	N/A	N/A	DWS Length (in)	N/A
N/A	Landing X Slope (%)	N/A	N/A	DWS Full Width?	N/A
N/A	Landing Curb? (Y/N)	N/A	N/A	DWS Offset (in)	N/A
N/A	Shared Landing?	N/A			
N/A	Gutter Ponding?	N/A	N/A	Gutter Slope (%)	N/A
N/A	Gutter Lip Ht (in)	N/A	N/A	Gutter X Slope (%)	N/A
N/A	Painted X Walk1?	No	N/A	Painted X Walk2?	N/A

**Remove & Replace Entire Ramp.**

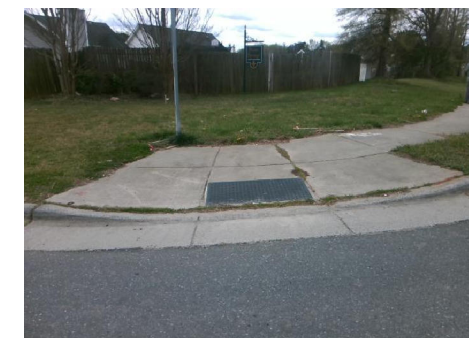
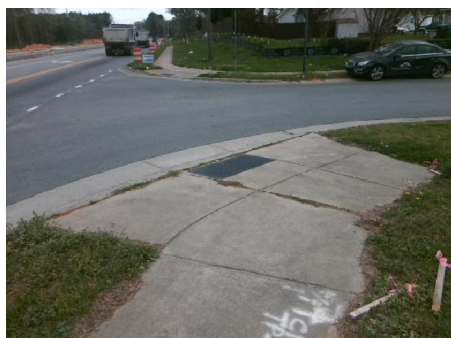
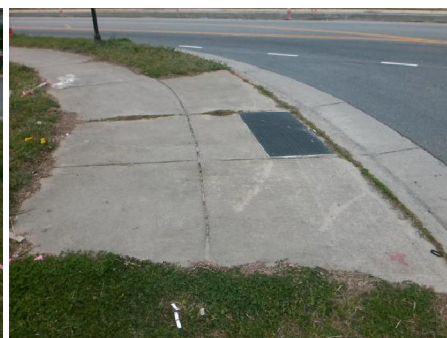
X Walk 1 Direction	To N		X Walk 2 Direction	N/A
	X Walk 1 Width (in)	N/A		X Walk 2 Width (in)	N/A
	X Walk 1 Slope (%)	1.9		X Walk 2 Slope (%)	N/A
	X Walk 1 X Slope (%)	2.1		X Walk 2 X Slope (%)	N/A
N/A	Ramp inside XWalk1?	N/A	N/A	Ramp inside XWalk2?	N/A
	Road Slope (%)	N/A		Clear Space?	N/A
	Road X Slope (%)	N/A	N/A	Clear Space to XWalk (in)	N/A
			N/A	Any Obstruction?	N/A
				Obstruction Type	N/A
			N/A	Storm Grate/Utility Hazard?	N/A
				Storm Grate/Utility Type	N/A
			Yes	Surface Condition? (G/P)	Good
				Curb Slope (%)	11.0
