Access Compliance Report

Public Rights-of-Way

(Curb Ramps)

Intersection ID: 50588	Main Street: BENDING_BRANCH_RD	Cross Street: DOWNY_BIRCH_RD	Location: SW
ADA ID: 95C47CE06DEB	Ramp Type: Perp	Initial Pass/Fail: Fail	Overall Compliance: No
Severity Score: 22.5			
Codes/Mitigation Info/Possible Solution		Field Measurements/Component Compliance

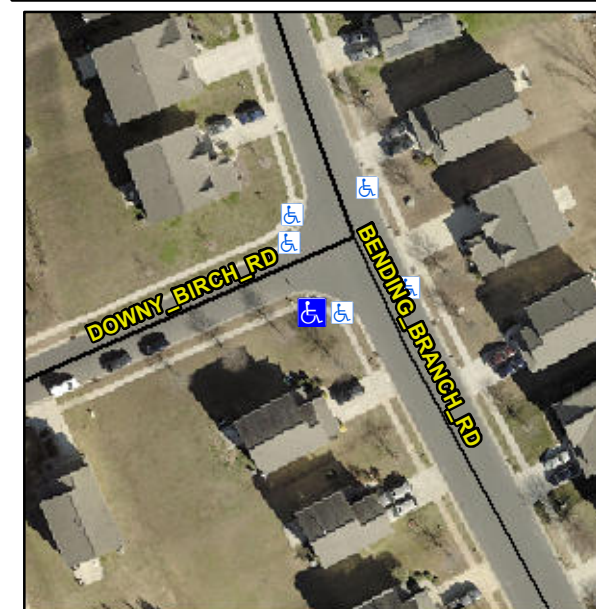
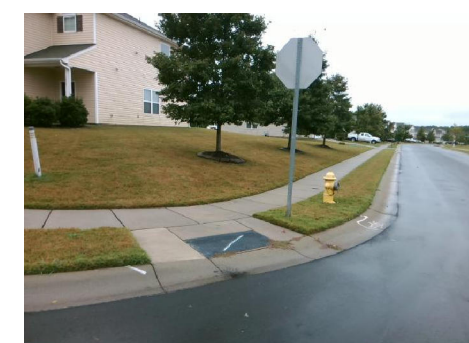
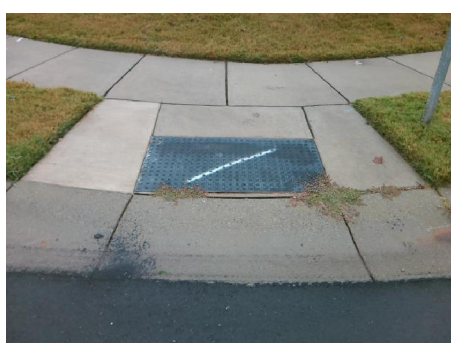
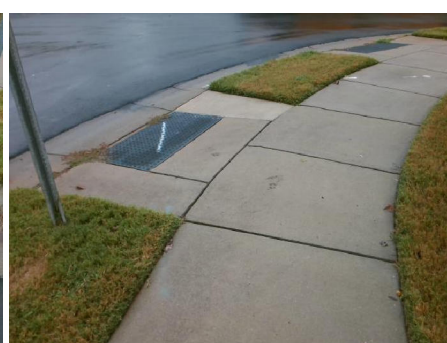
Not Found, R304.5.1, R304.2.2, R304.5.3

Compliance	Description	Data	Compliance	Description	Data
N/A	Ramp Length (in)	46.0	No	Ramp Slope (%)	10.9
No	Ramp Width (in)	47.5	No	Ramp XSlope (%)	4.1
N/A	Flare Type LT	N/A	N/A	Flare Type RT	N/A
N/A	Flare Slope LT (%)	N/A	N/A	Flare Slope RT (%)	N/A
N/A	Flare Traversable LT?	N/A	N/A	Flare Traversable RT?	N/A
N/A	Landing Length (in)	N/A	N/A	DWS Provided?	N/A
N/A	Landing Width (in)	N/A	N/A	DWS Contrast?	N/A
N/A	Landing Slope (%)	N/A	N/A	DWS Length (in)	N/A
N/A	Landing X Slope (%)	N/A	N/A	DWS Full Width?	N/A
N/A	Landing Curb? (Y/N)	N/A	N/A	DWS Offset (in)	N/A
N/A	Shared Landing?	N/A			
N/A	Gutter Ponding?	N/A	N/A	Gutter Slope (%)	N/A
N/A	Gutter Lip Ht (in)	N/A	N/A	Gutter X Slope (%)	N/A
N/A	Painted X Walk1?	No	N/A	Painted X Walk2?	N/A
	X Walk 1 Direction	To N		X Walk 2 Direction	N/A
N/A	X Walk 1 Width (in)	N/A	N/A	X Walk 2 Width (in)	N/A
	X Walk 1 Slope (%)	0.9		X Walk 2 Slope (%)	N/A
	X Walk 1 X Slope (%)	2.9		X Walk 2 X Slope (%)	N/A

N/A	Ramp inside XWalk1?	N/A	N/A	Ramp inside XWalk2?	N/A
	Road Slope (%)	N/A	N/A	Clear Space?	N/A
	Road X Slope (%)	N/A	N/A	Clear Space to XWalk (in)	N/A
N/A	Any Obstructions?	N/A	N/A	Storm Grate/Utility Hazard?	N/A
	Obstruction Type			Storm Grate/Utility Type	
		N/A			N/A
			Yes	Surface Condition? (G/P)	Good

Remove & Replace Entire Ramp.
