Access Compliance Report

Public Rights-of-Way

(Curb Ramps)

Intersection ID: 2928	Main Street: PROSPERITY_CHURCH_RD	Cross Street: RIDGE_RD	Location: SW
ADA ID: 95CBF1806BCC	Ramp Type: PerpDiag	Initial Pass/Fail: Fail	Overall Compliance: No
Severity Score: 33.75			
Codes/Mitigation Info/Possible Solution		Field Measurements/Component Compliance

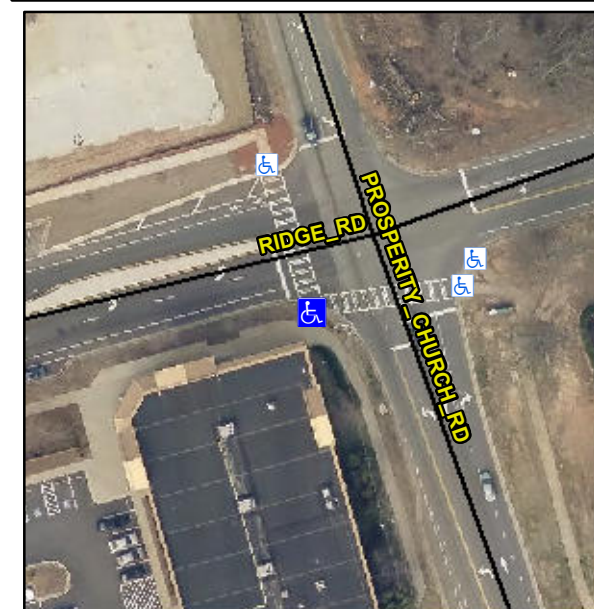
Compliance	Description	Data	Compliance	Description	Data
N/A	Ramp Length (in)	98.0	No	Ramp Slope (%)	13.9
No	Ramp Width (in)	41.5	Yes	Ramp XSlope (%)	1.2
N/A	Flare Type LT	N/A	N/A	Flare Type RT	N/A
N/A	Flare Slope LT (%)	N/A	N/A	Flare Slope RT (%)	N/A
N/A	Flare Traversable LT?	N/A	N/A	Flare Traversable RT?	N/A
N/A	Landing Length (in)	N/A	N/A	DWS Provided?	N/A
N/A	Landing Width (in)	N/A	N/A	DWS Contrast?	N/A
N/A	Landing Slope (%)	N/A	N/A	DWS Length (in)	N/A
N/A	Landing X Slope (%)	N/A	N/A	DWS Full Width?	N/A
N/A	Landing Curb? (Y/N)	N/A	N/A	DWS Offset (in)	N/A
N/A	Shared Landing?	N/A			
N/A	Gutter Ponding?	N/A	N/A	Gutter Slope (%)	N/A
N/A	Gutter Lip Ht (in)	N/A	N/A	Gutter X Slope (%)	N/A
N/A	Painted X Walk1?	Yes	N/A	Painted X Walk2?	Yes
	X Walk 1 Direction	To E		X Walk 2 Direction	To N
N/A	X Walk 1 Width (in)	111.0	N/A	X Walk 2 Width (in)	122.0
	X Walk 1 Slope (%)	2.9		X Walk 2 Slope (%)	3.8
	X Walk 1 X Slope (%)	3.8		X Walk 2 X Slope (%)	4.1

N/A	Ramp inside XWalk1?	Yes	N/A	Ramp inside XWalk2?	Yes
	Road Slope (%)	2.5	N/A	Clear Space?	N/A
	Road X Slope (%)	4.8	N/A	Clear Space to XWalk (in)	N/A
N/A	Any Obstructions?	N/A	N/A	Storm Grate/Utility Hazard?	N/A
	Obstruction Type			Storm Grate/Utility Type	
		N/A			N/A
		Yes		Surface Condition? (G/P)	Good

Possible Solutions:

Remove & Replace Curb Ramp With Two New Directional Ramps or Equivalent.
