Access Compliance Report

Public Rights-of-Way

(Curb Ramps)

Intersection ID: 10038888	Main Street: STINSON_CT	Cross Street: N/A	Location:	N
ADA ID: 95D038D5137C	Ramp Type: Perp	Initial Pass/Fail: Fail	Overall Compliance: No	Severity Score: 10
Codes/Mitigation Info/Possible Solution		Field Measurements/Component Compliance

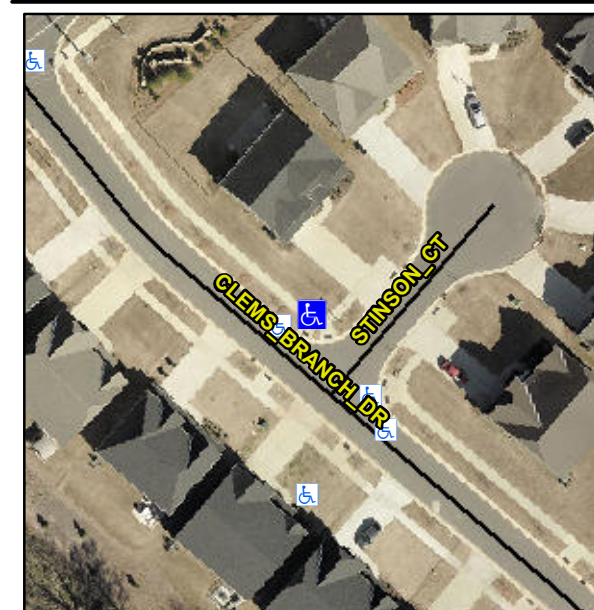
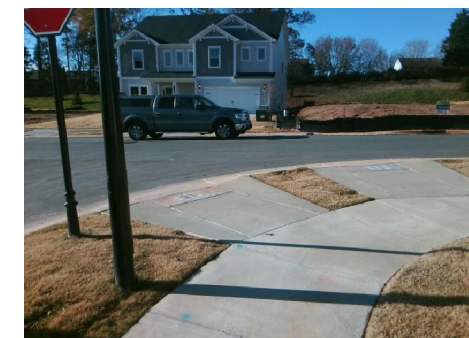
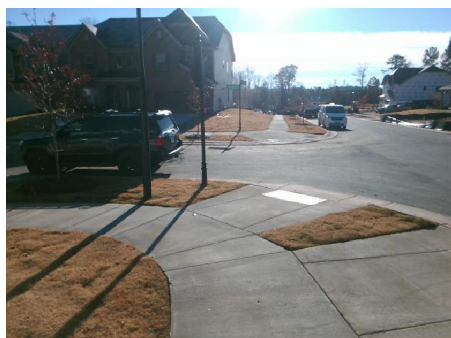
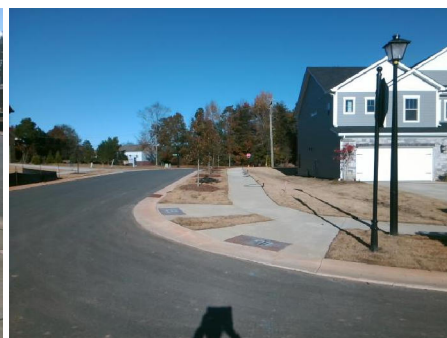
Compliance	Description	Data	Compliance	Description	Data
N/A	Ramp Length (in)	100.0	Yes	Ramp Slope (%)	5.5
No	Ramp Width (in)	47.0	No	Ramp XSlope (%)	4.1
N/A	Flare Type LT	N/A	N/A	Flare Type RT	N/A
N/A	Flare Slope LT (%)	N/A	N/A	Flare Slope RT (%)	N/A
N/A	Flare Traversable LT?	N/A	N/A	Flare Traversable RT?	N/A
N/A	Landing Length (in)	N/A	N/A	DWS Provided?	N/A
N/A	Landing Width (in)	N/A	N/A	DWS Contrast?	N/A
N/A	Landing Slope (%)	N/A	N/A	DWS Length (in)	N/A
N/A	Landing X Slope (%)	N/A	N/A	DWS Full Width?	N/A
N/A	Landing Curb? (Y/N)	N/A	N/A	DWS Offset (in)	N/A
N/A	Shared Landing?	N/A			
N/A	Gutter Ponding?	N/A	N/A	Gutter Slope (%)	N/A
N/A	Gutter Lip Ht (in)	N/A	N/A	Gutter X Slope (%)	N/A
N/A	Painted X Walk1?	No	N/A	Painted X Walk2?	N/A
	X Walk 1 Direction	To SE		X Walk 2 Direction	N/A
N/A	X Walk 1 Width (in)	N/A	N/A	X Walk 2 Width (in)	N/A
	X Walk 1 Slope (%)	1.8		X Walk 2 Slope (%)	N/A
	X Walk 1 X Slope (%)	4.6		X Walk 2 X Slope (%)	N/A

N/A	Ramp inside XWalk1?	N/A	N/A	Ramp inside XWalk2?	N/A
	Road Slope (%)	N/A	N/A	Clear Space?	N/A
	Road X Slope (%)	N/A	N/A	Clear Space to XWalk (in)	N/A
N/A	Any Obstructions?	N/A	N/A	Storm Grate/Utility Hazard?	N/A
	Obstruction Type			Storm Grate/Utility Type	
		N/A			N/A
			Yes	Surface Condition? (G/P)	Good

Possible Solutions:

Remove & Replace Entire Ramp.

R304.5.1, R304.5.3
